Dorman Long Tower South Bank, Teesworks

South Tees Development Corporation

Structural Appraisal Report

Document reference: STDC-ATK-SBK-ZZ-RP-S-0001

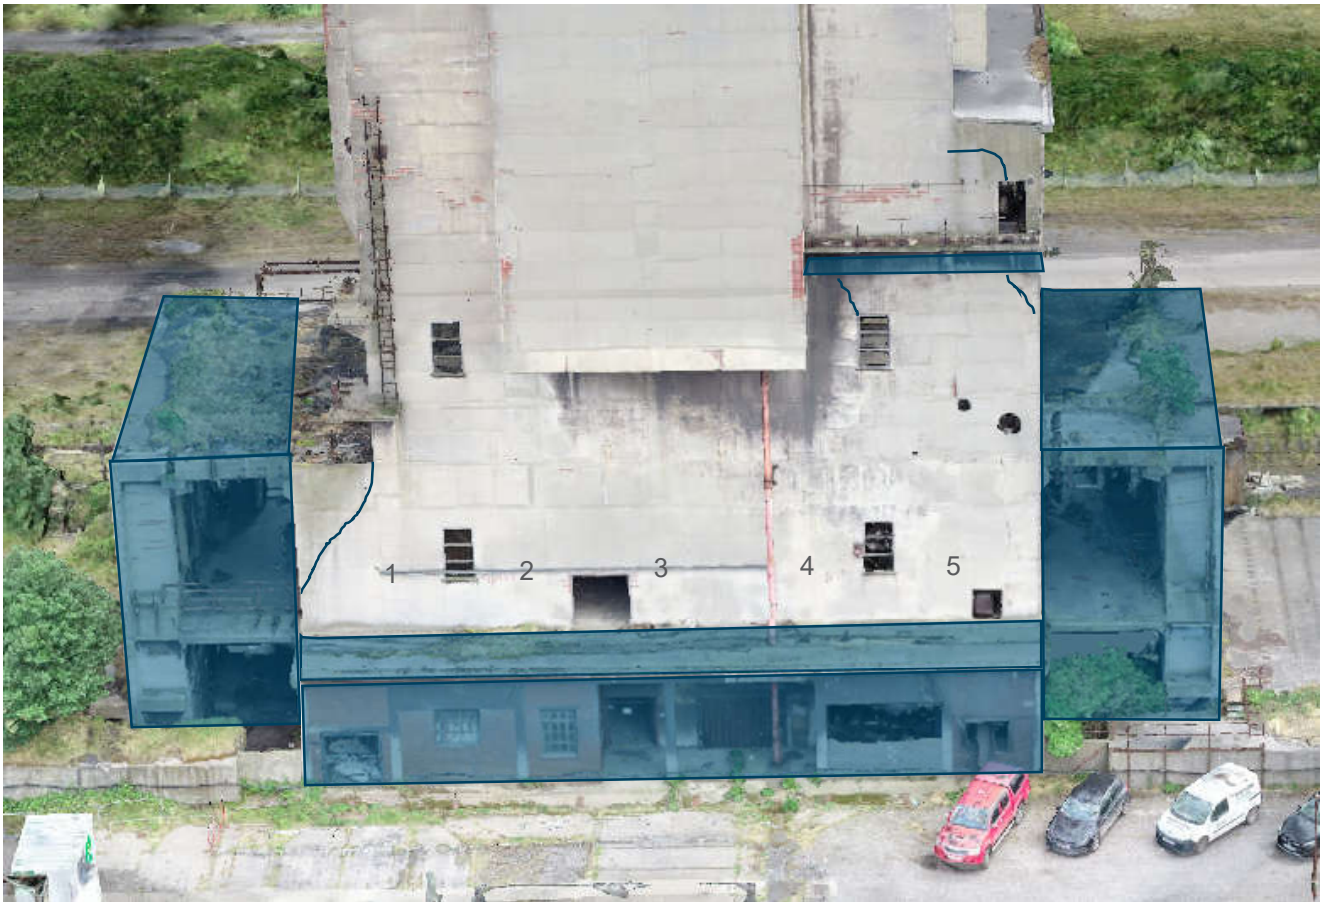
5.2. Northern Elevation

The shaded areas are the east, west and northern low-level extensions. All are in very poor condition and do not contribute to the overall stability of the tower.

The main cracking has been highlighted in black. These cracks indicate that the outlying wall panels are trying to disperse lateral loads, something they may not have been designed to do. Note that almost all of the cracking lies outside the line of the main outer columns, numbered 1 to 5. The outstand bay on the right, supporting the spillage and testing office also has a number of large service penetrations

It is recommended that in the case of the tower remaining these are cut back and removed due to their overall poor condition.

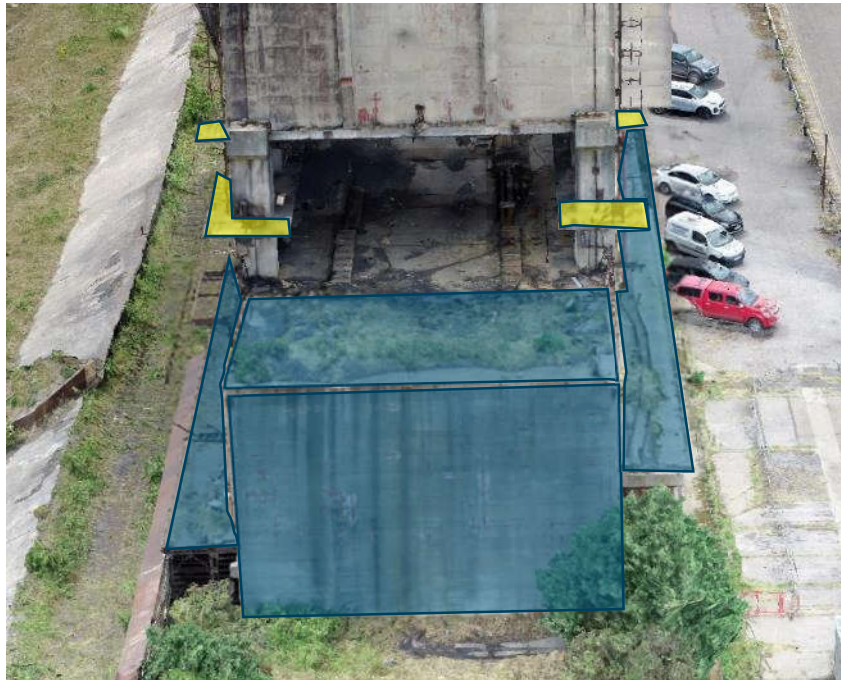
5.3. Eastern Elevation

The shaded areas are the east, northern and southern low-level extensions. All are in poor condition and do not contribute to the overall stability of the tower. It is recommended that in the case of the tower remaining these are cut back and removed due to their overall poor condition.

There is no significant cracking of note on this elevation.

Also note the concrete corbels, landings and platforms that should be removed if the structure is to be retained, highlighted in yellow.

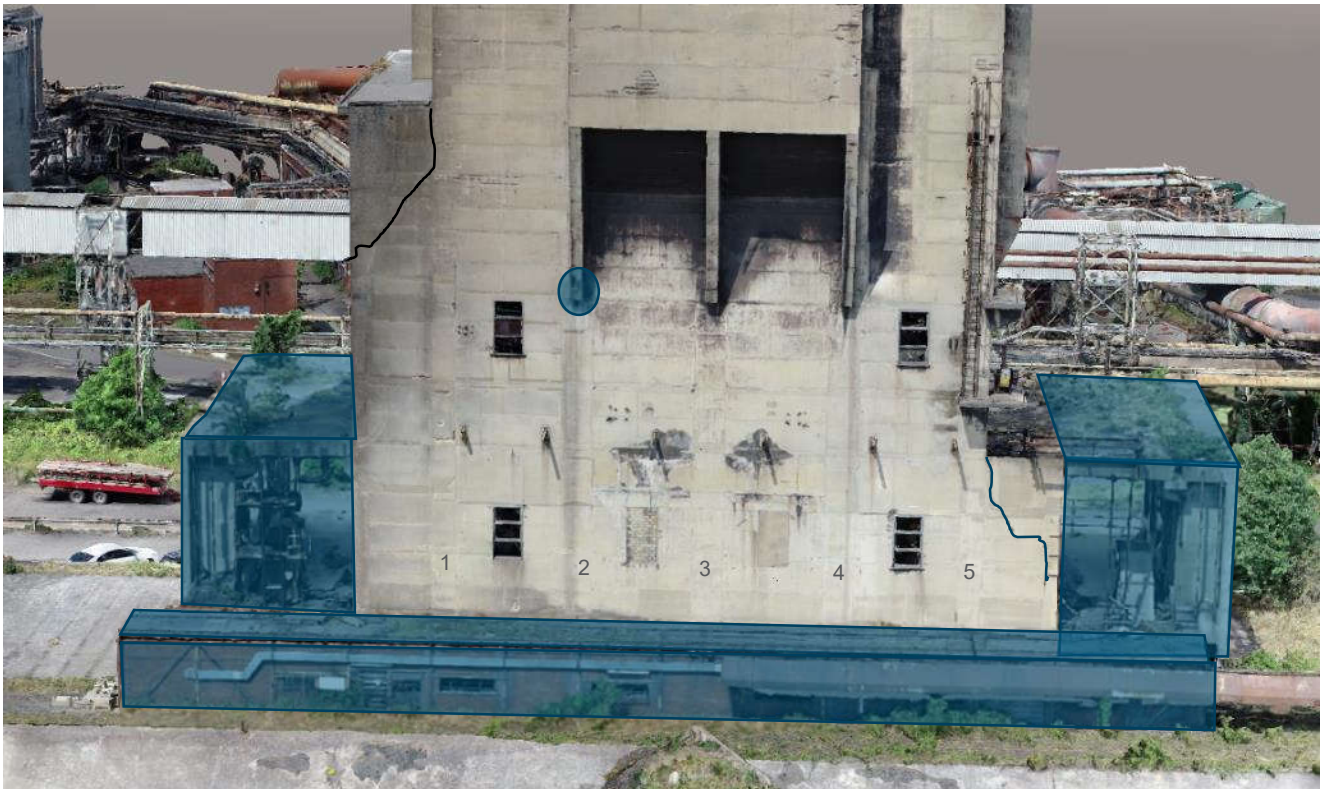
5.4. Southern Elevation

The shaded areas are the east, west and southern low-level extensions. All are in poor condition and do not contribute to the overall stability of the tower. It is recommended that in the case of the tower remaining these are cut back and removed due to their overall poor condition.

The main cracking has been highlighted in black. These cracks indicate that the outlying wall panels are trying to disperse loads, something they may not have been designed to do. Note that all of the major cracking lies outside the line of the main outer columns, numbered 1 to 5.

The oval indicates an area of heavy spalling and corrosion at the tips of the three concrete wall corbels. We suspect this area is affected because of the high density of steel reinforcement in this area and the limited concrete cover.

Also note the numerous steelwork brackets, corbels, cables and ladders that all need to be removed if the structure is to be retained.

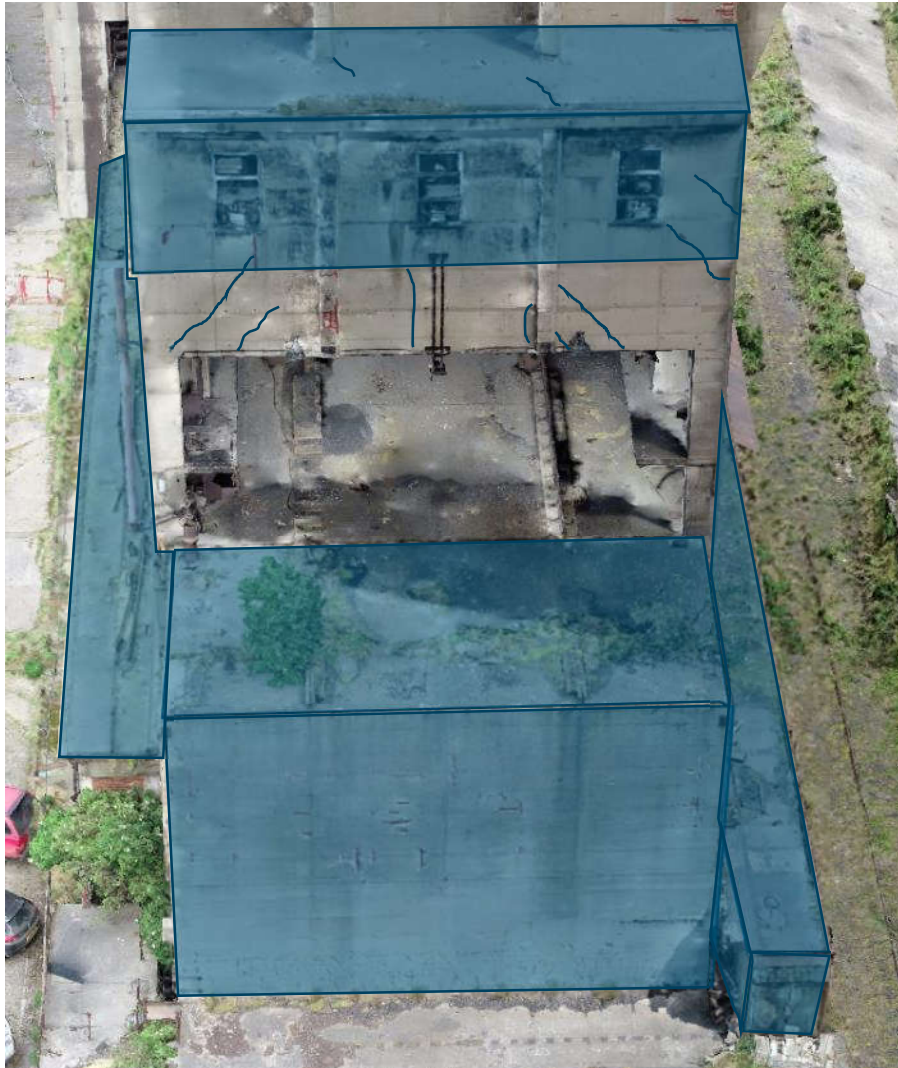
5.5. Western Elevation

The shaded areas are the west, southern and northern low-level extensions and the spillage/testing room. All are in poor condition and do not contribute to the overall stability of the tower. The lower (thicker) half of the testing room wall is structural and must be retained. It is recommended that in the case of the tower remaining these shaded areas are cut back and removed due to their overall poor condition.

The main cracking has been highlighted in black. These cracks indicate that the end wall panels of the spillage and testing room is trying to span across the opening as a beam, again trying to spread load that it may not have been designed to resist.

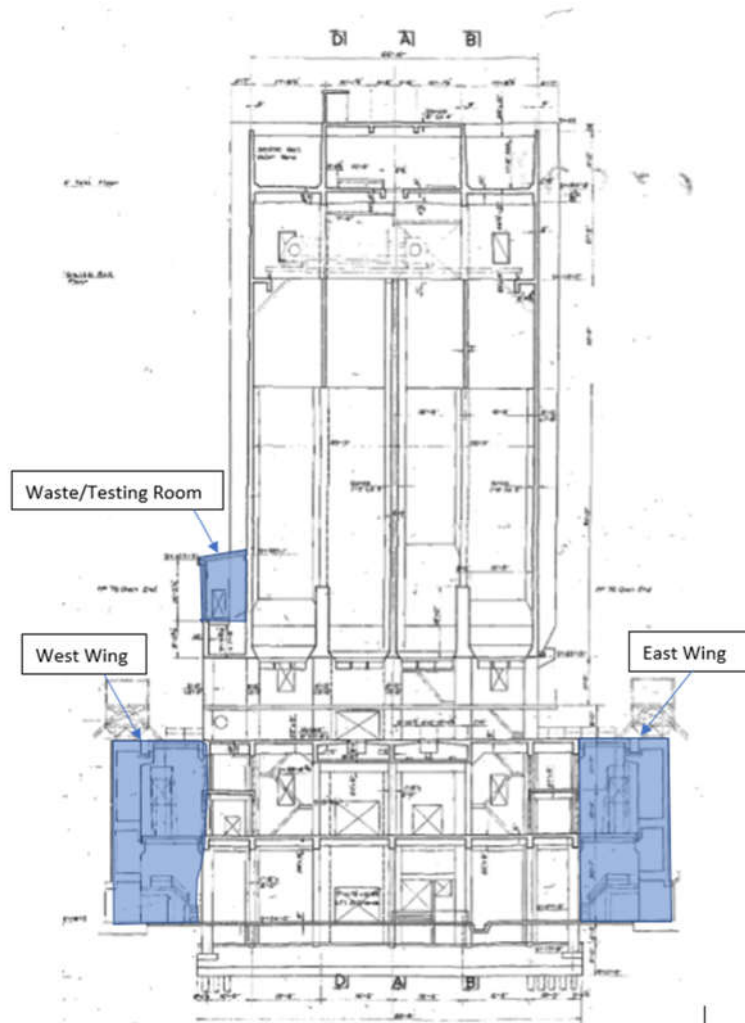
Figure 9.1 - Concrete portions to be removed in the Do Nothing, Basic Repair and Make Safe option.

Note that in order to carry out some of this work, temporary internal and external access will be required.

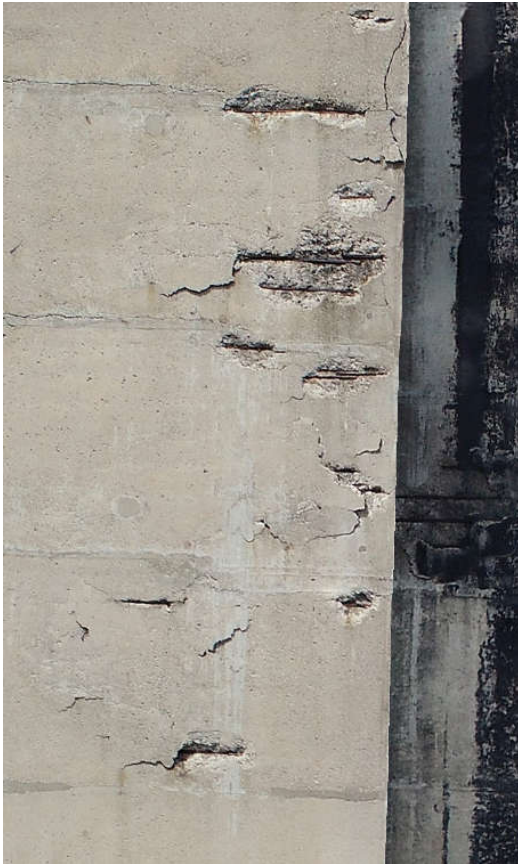
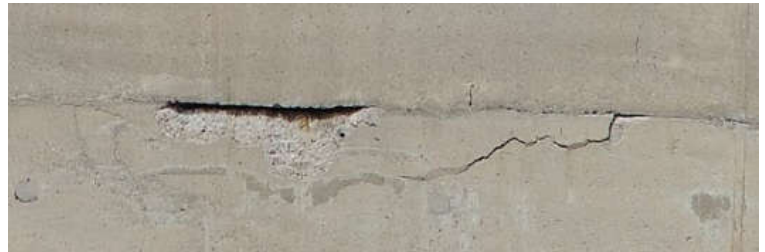
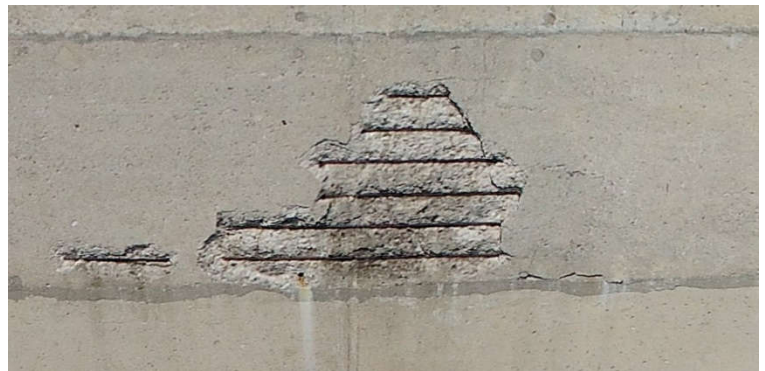
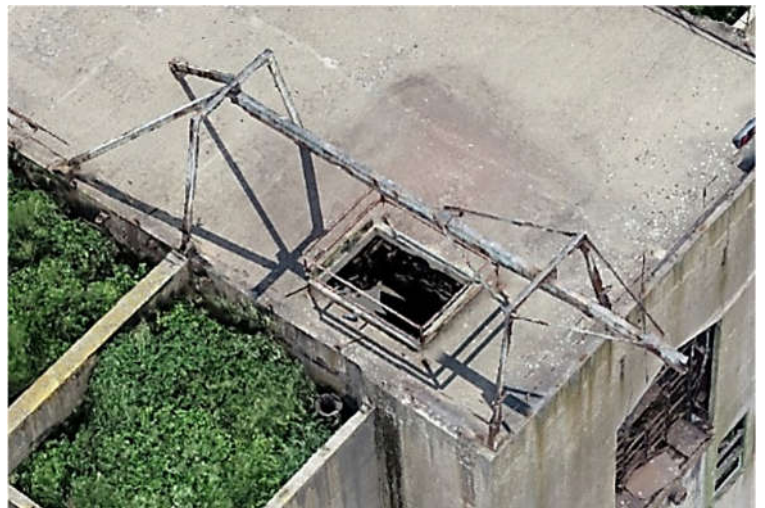
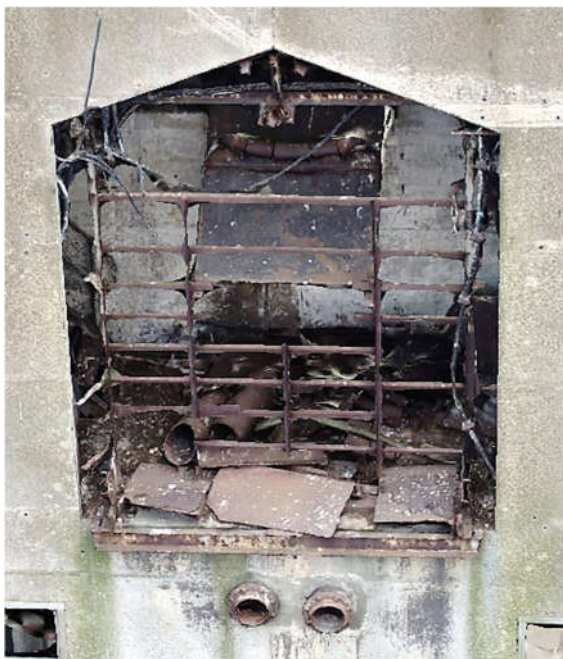
We recommend that as soon as practicable a health and safety HAZID is carried out to consider the risks of falling debris and consider providing an exclusion zone 3 to 5 m wide around the tower. This exclusion zone would provide a secure zone for debris to fall into. This area should be secure and have appropriate signage. Some examples of at-risk items is shown in the Figures below:

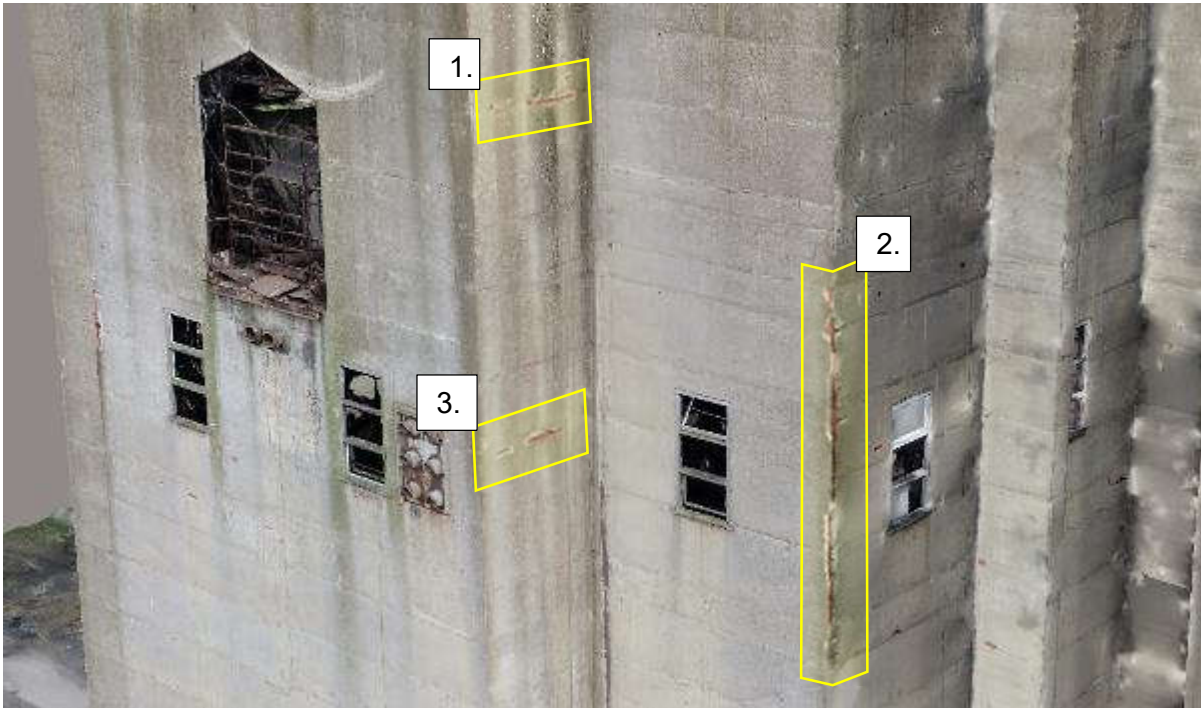
Figure 2: North Elevation - Defects 1-3

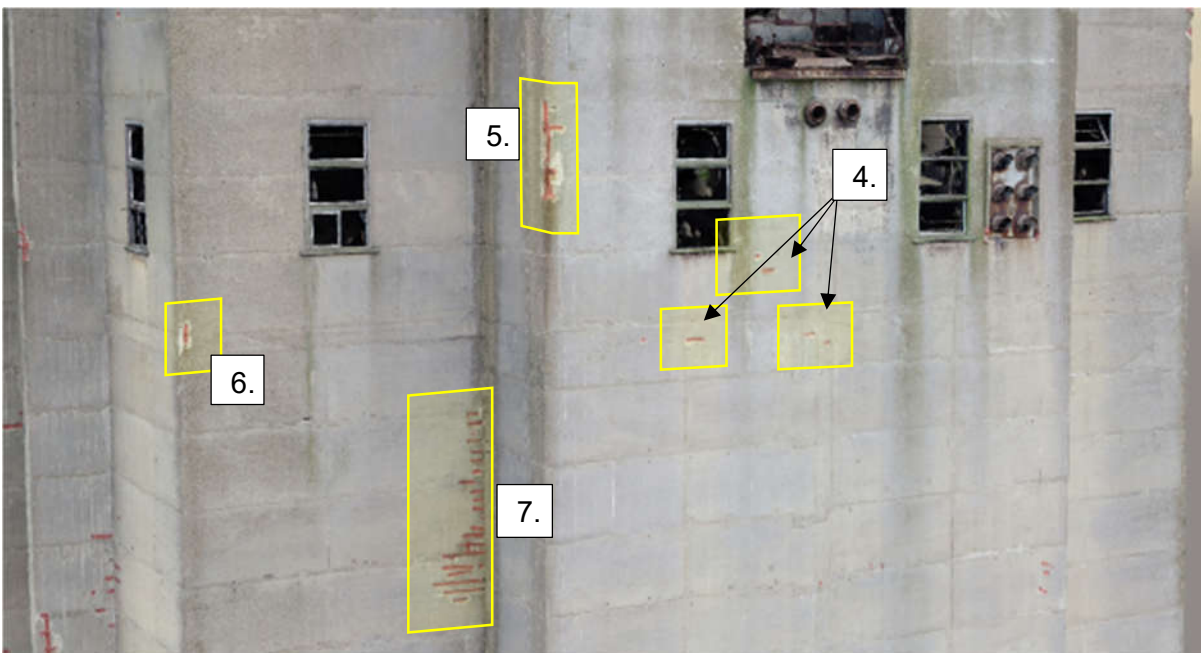
Figure 3: North Elevation - Defects 4-7

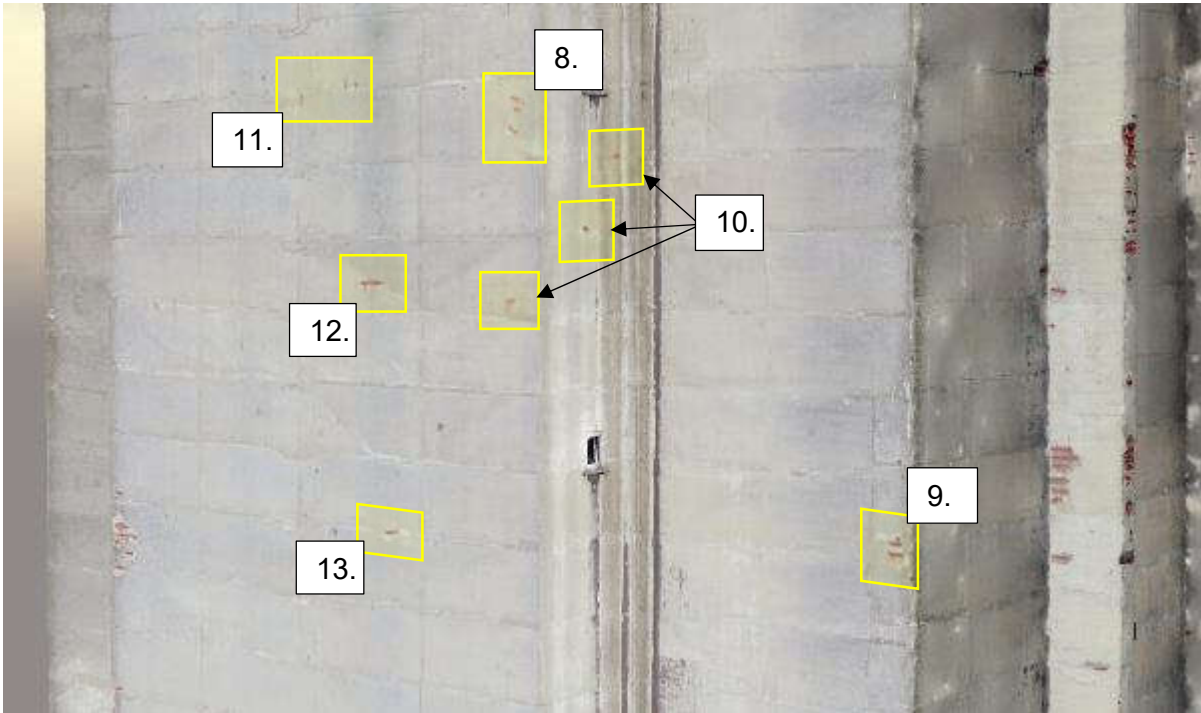
Figure 4: North Elevation - Defects 8-13

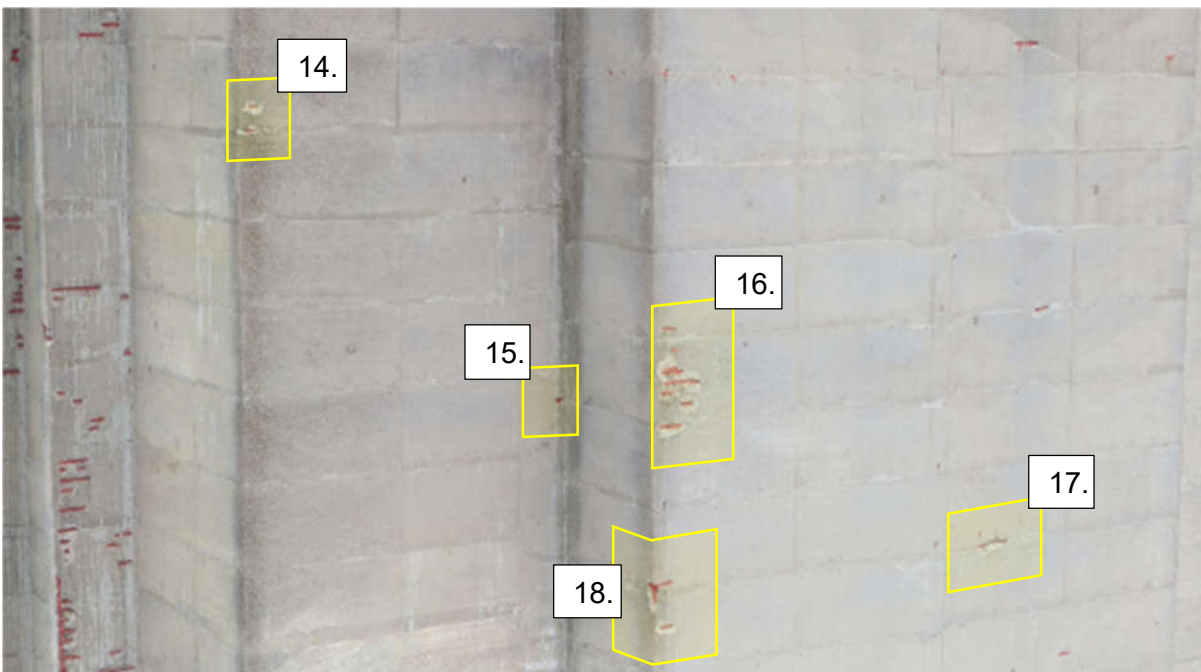
Figure 5: North Elevation - Defects 14-18

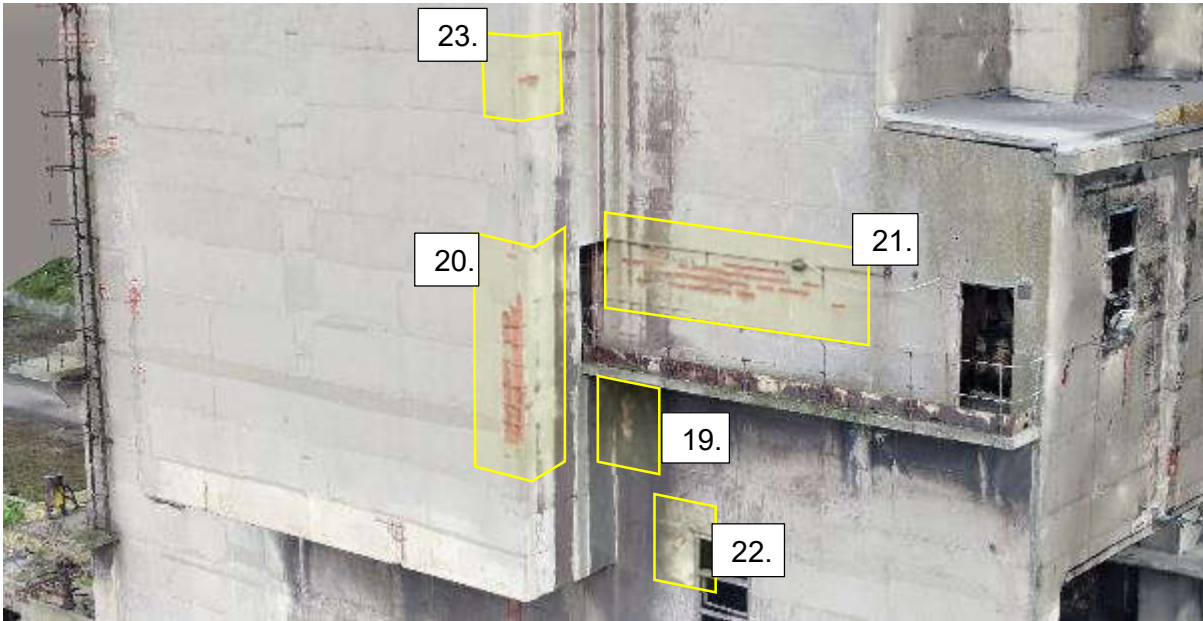
Figure 6: North Elevation - Defects 19-23

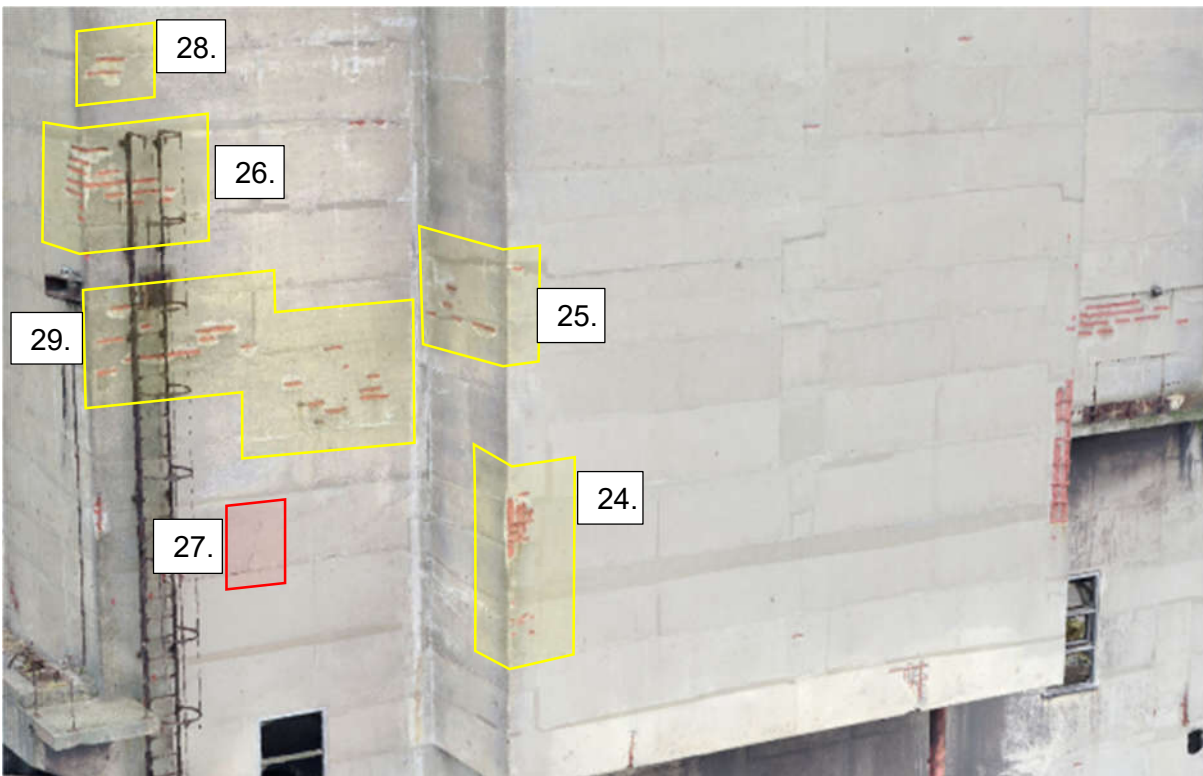
Figure 7: North Elevation - Defects 24-29

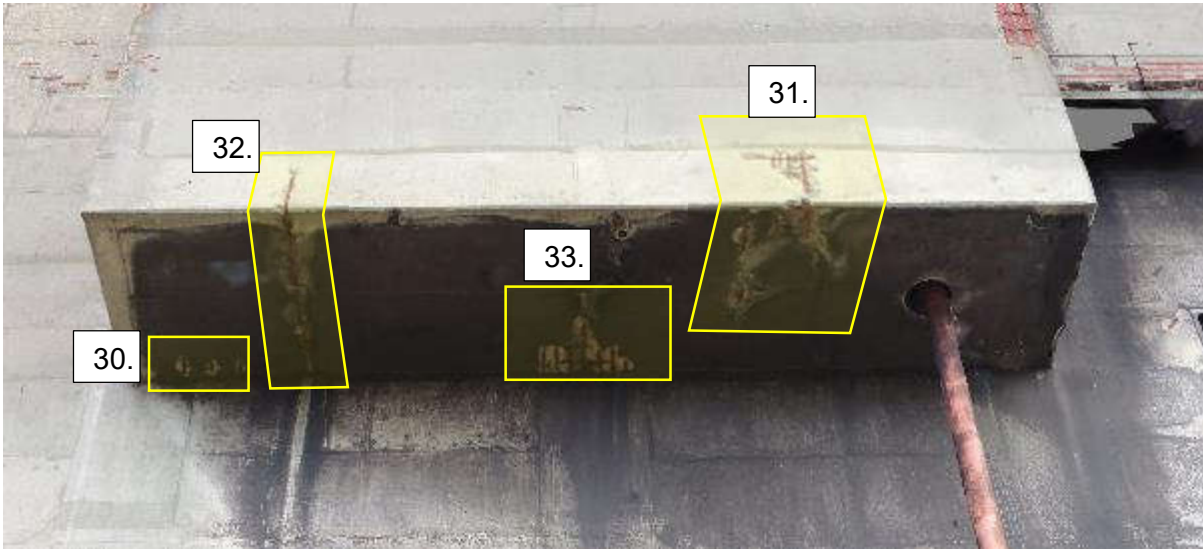
Figure 8: North Elevation - Defects 30-33

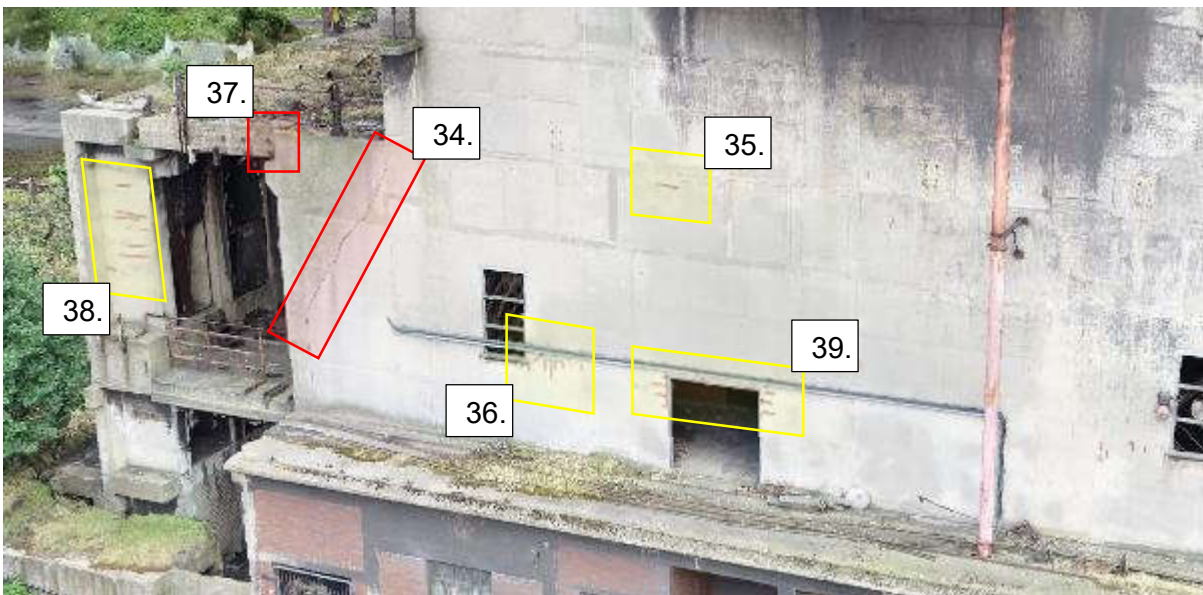
Figure 9: North Elevation - Defects 34-39

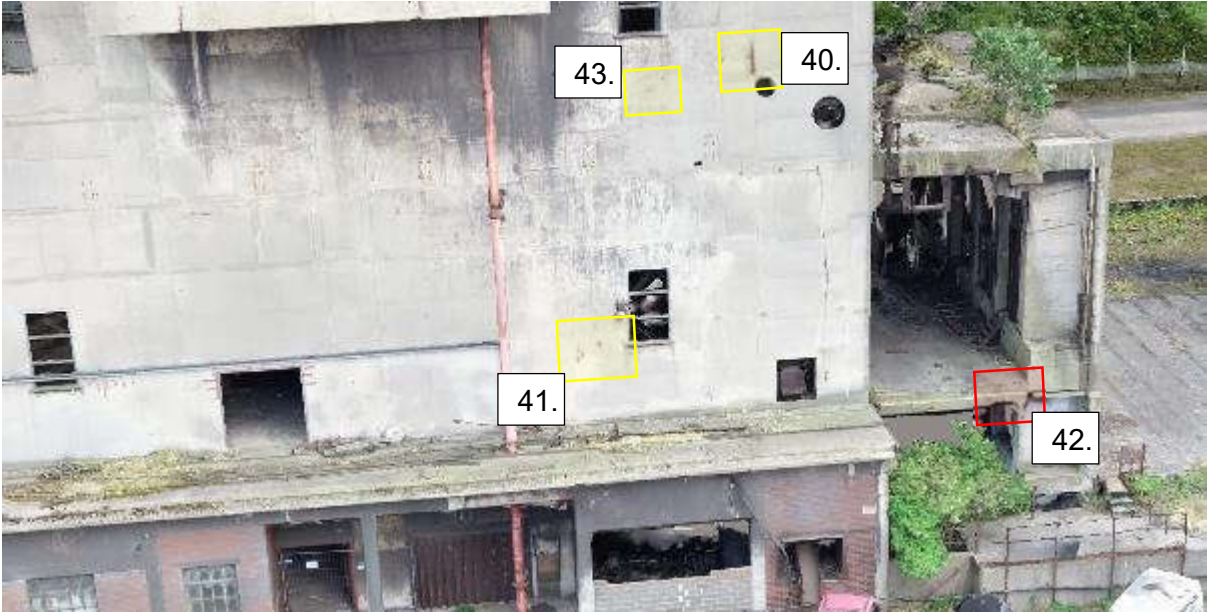
Figure 10: North Elevation - Defects 40-43

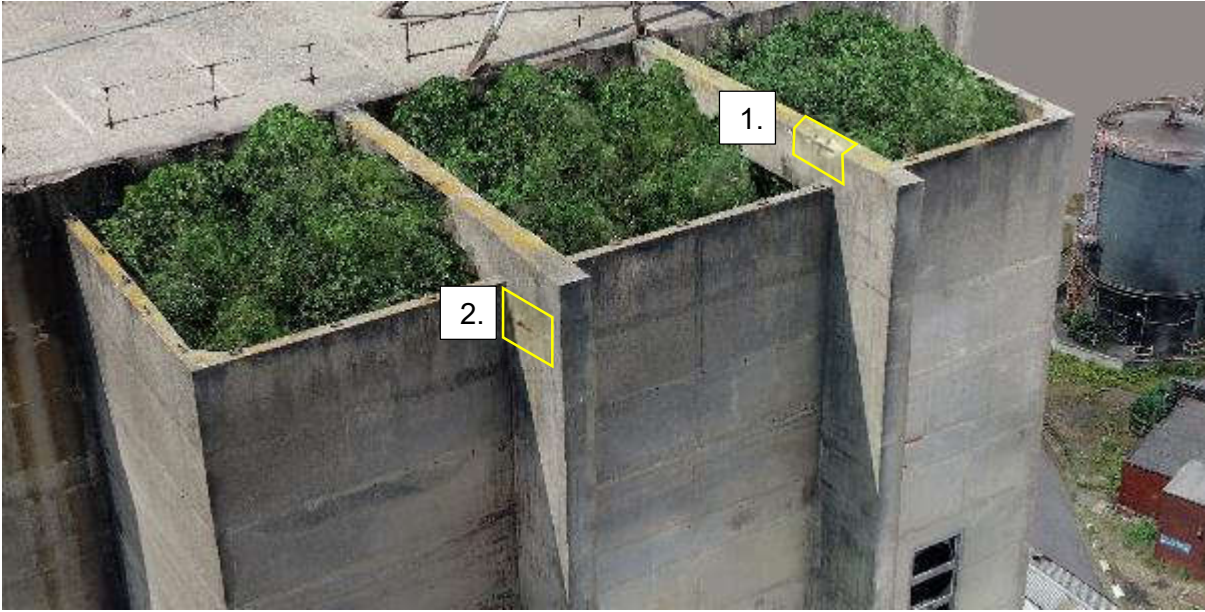
Figure 12: East Elevation - Defects 1-2

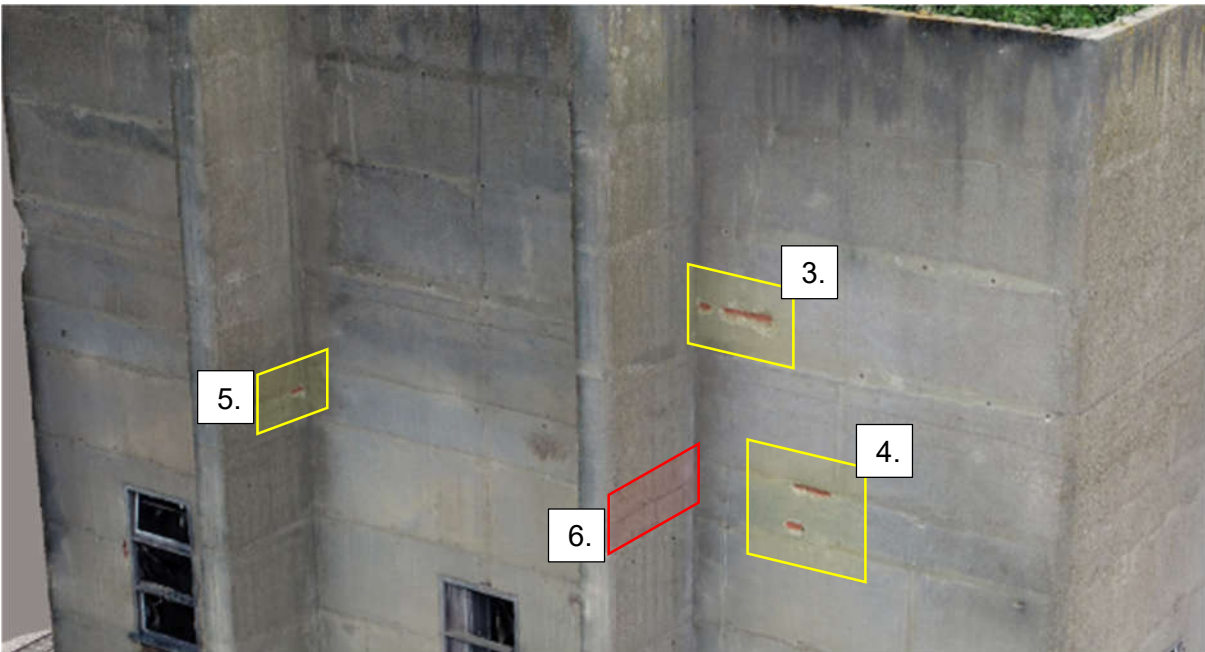
Figure 13: East Elevation - Defects 3-6

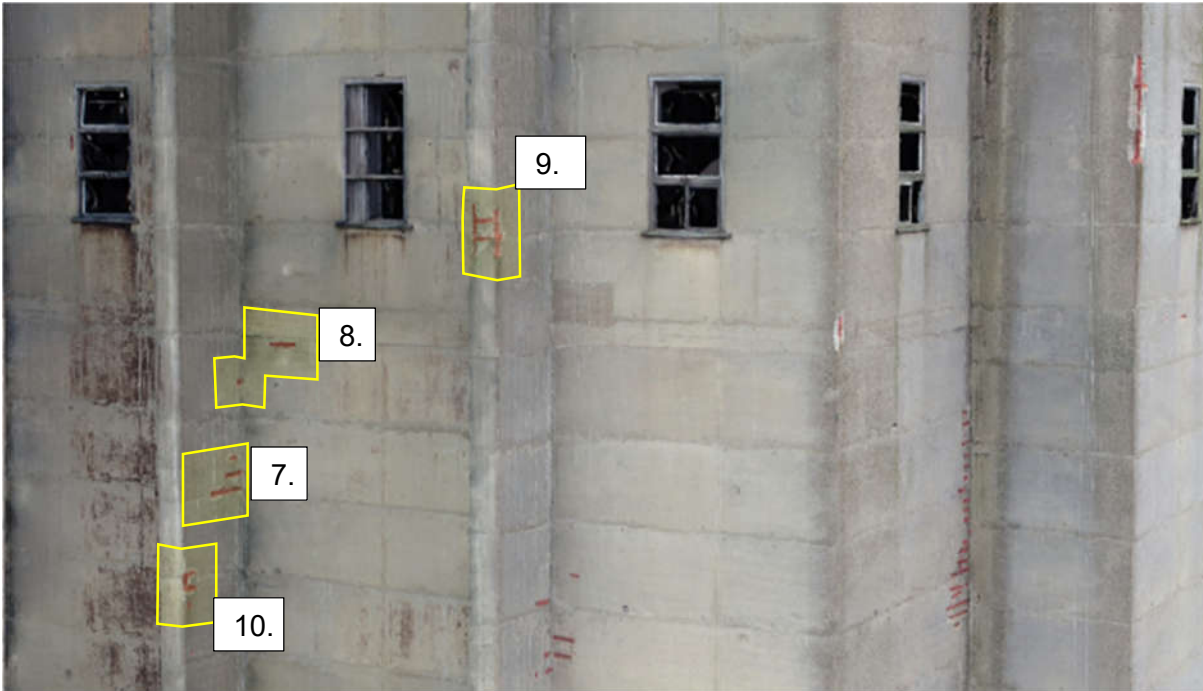
Figure 14: East Elevation - Defects 7-10

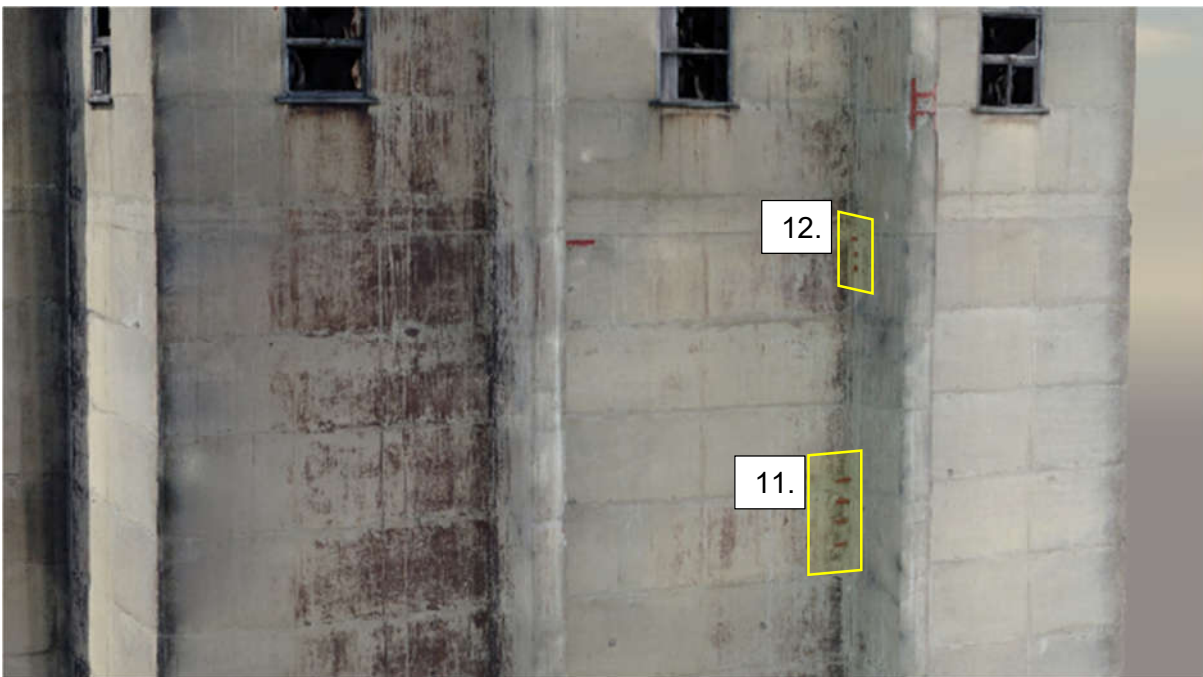
Figure 15: East Elevation - Defects 11-12

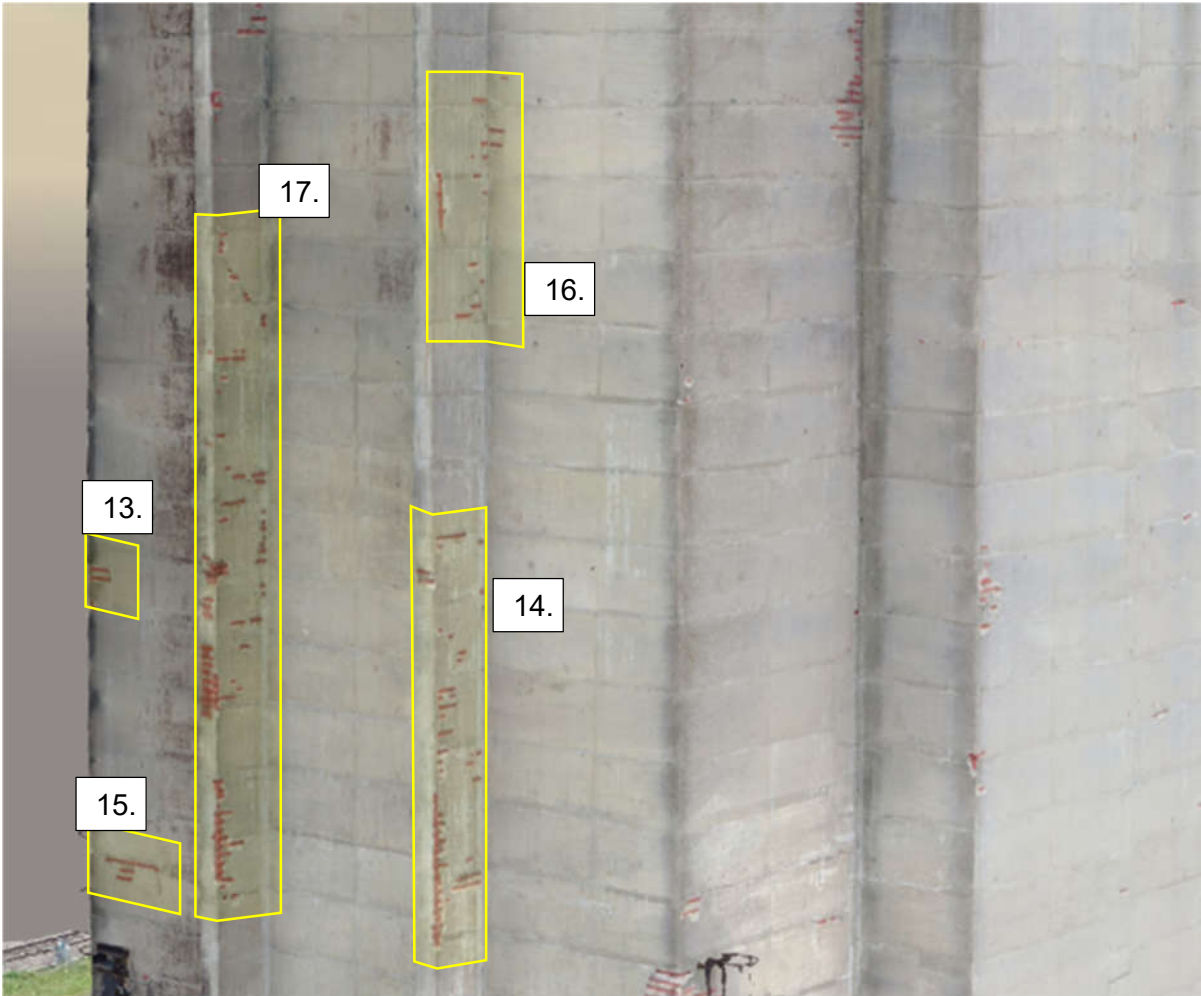
Figure 16: East Elevation - Defects 13-17

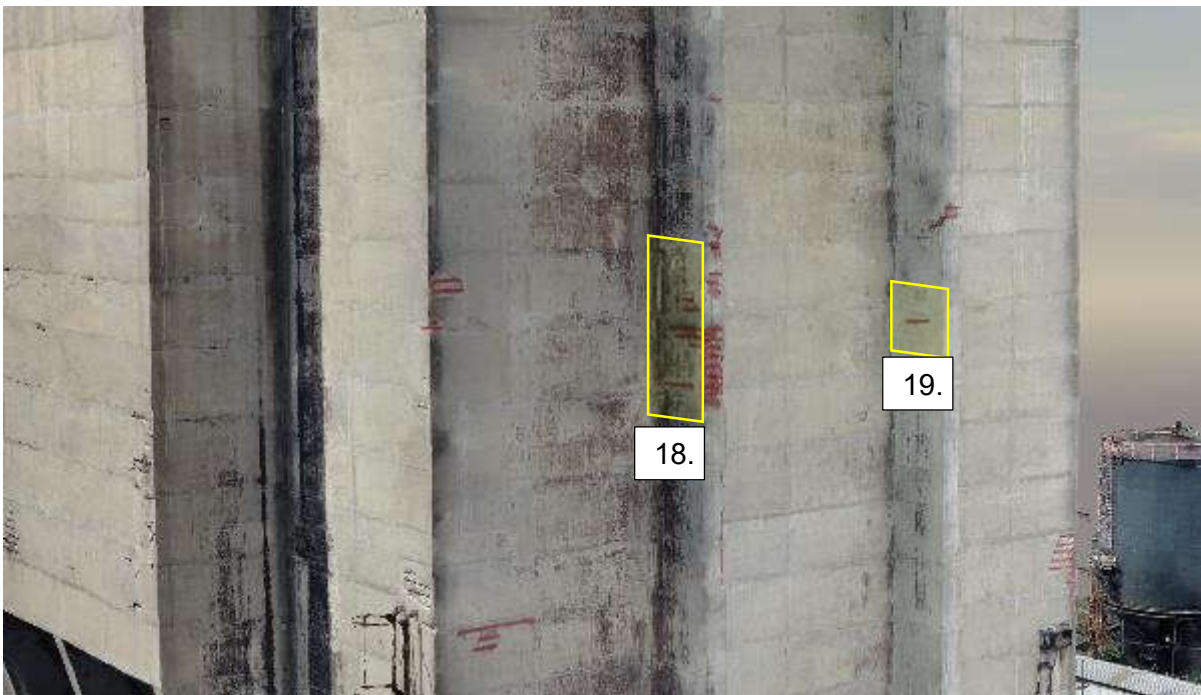
Figure 17: East Elevation - Defects 18-19

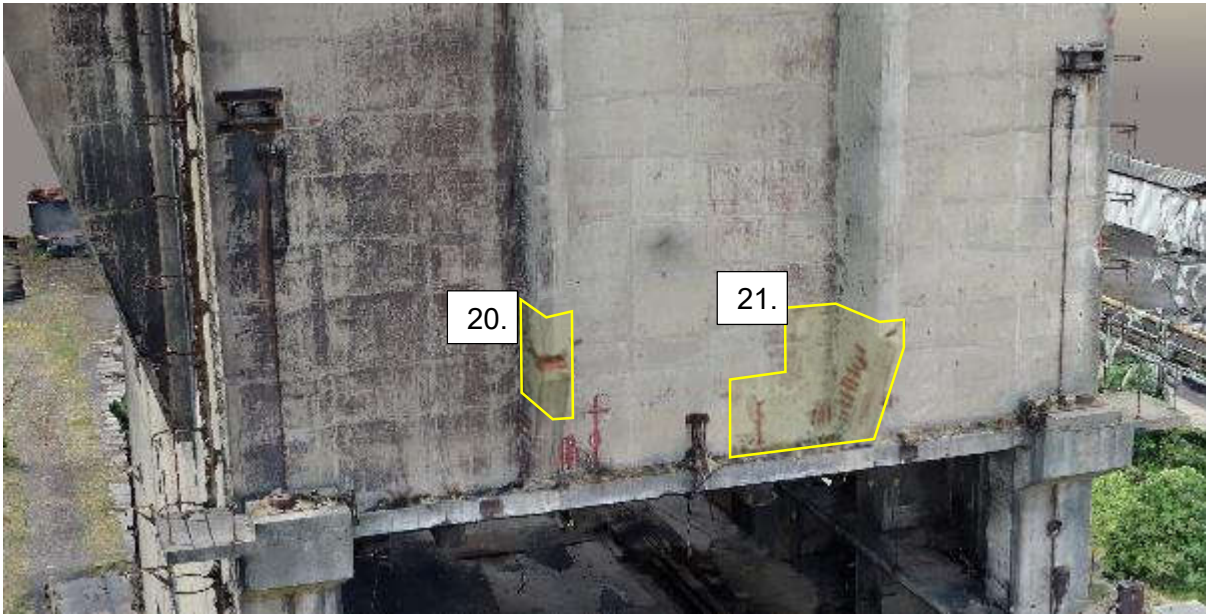
Figure 18: East Elevation - Defects 20-21

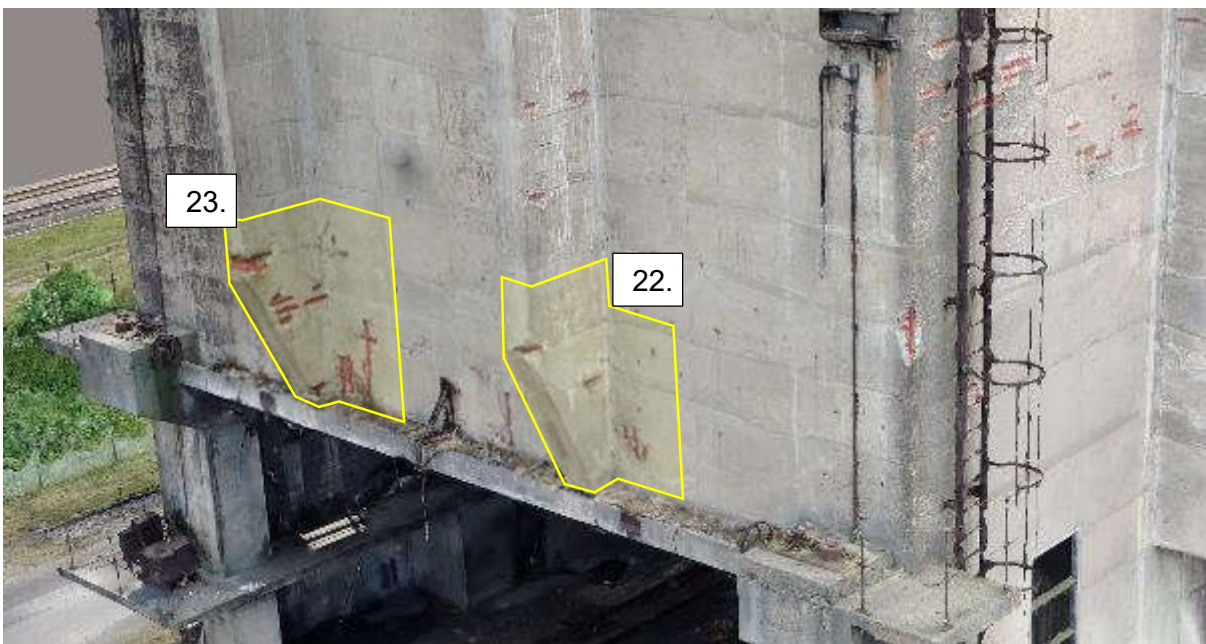
Figure 19: East Elevation - Defects 22-23

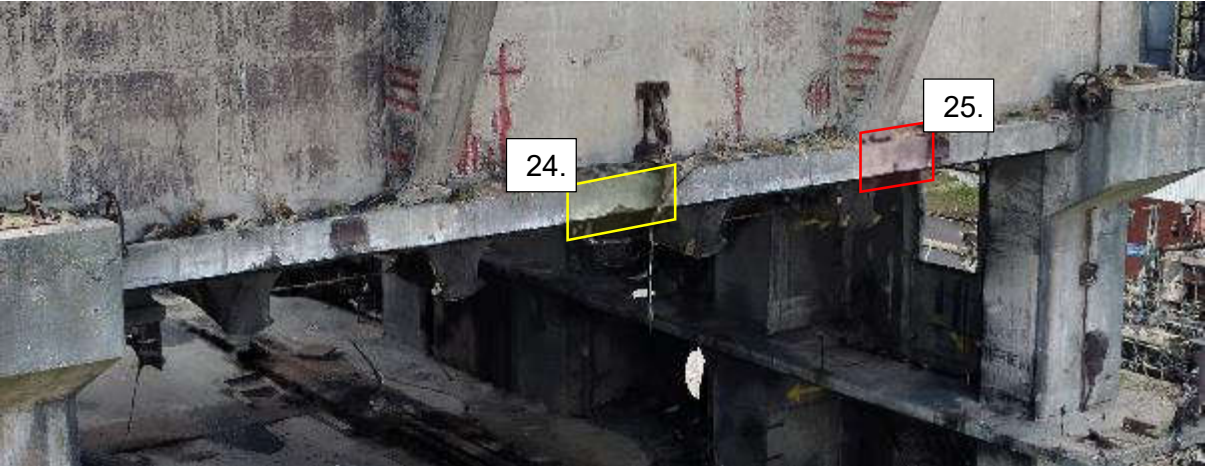
Figure 20: East Elevation - Defects 24-25

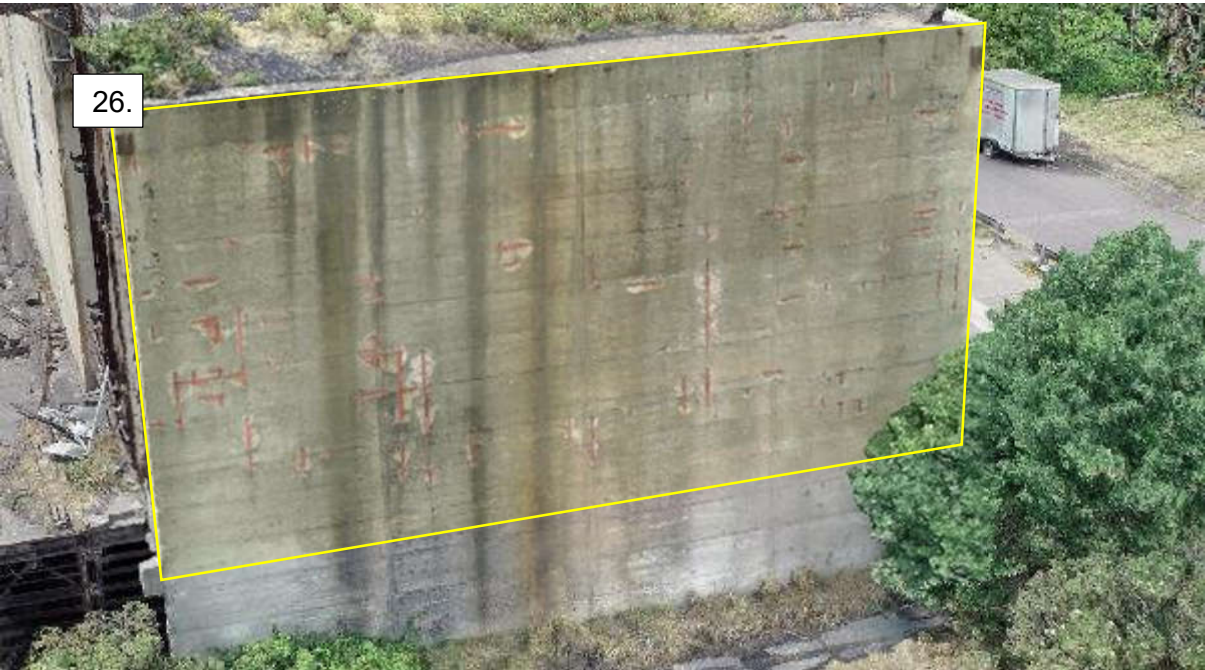
Figure 21: East Elevation - Defect 26
