Dorman Long Tower South Bank, Teesworks

South Tees Development Corporation

Structural Appraisal Report

Document reference: STDC-ATK-SBK-ZZ-RP-S-0001

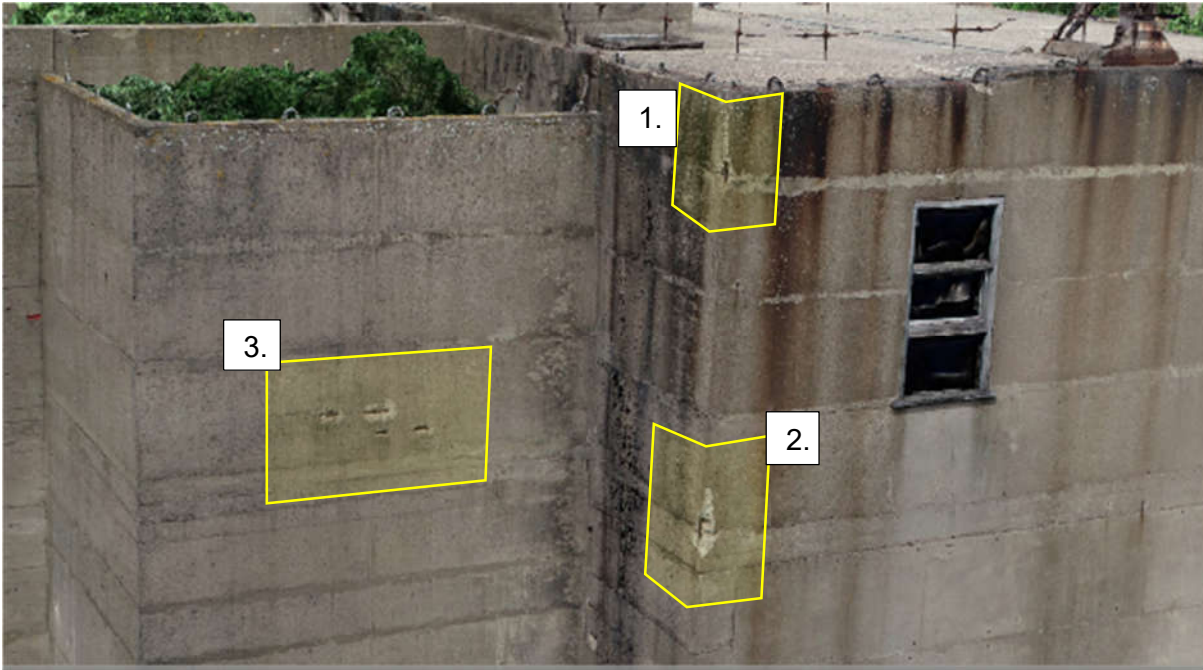
Figure 23: South Elevation - Defects 1-3

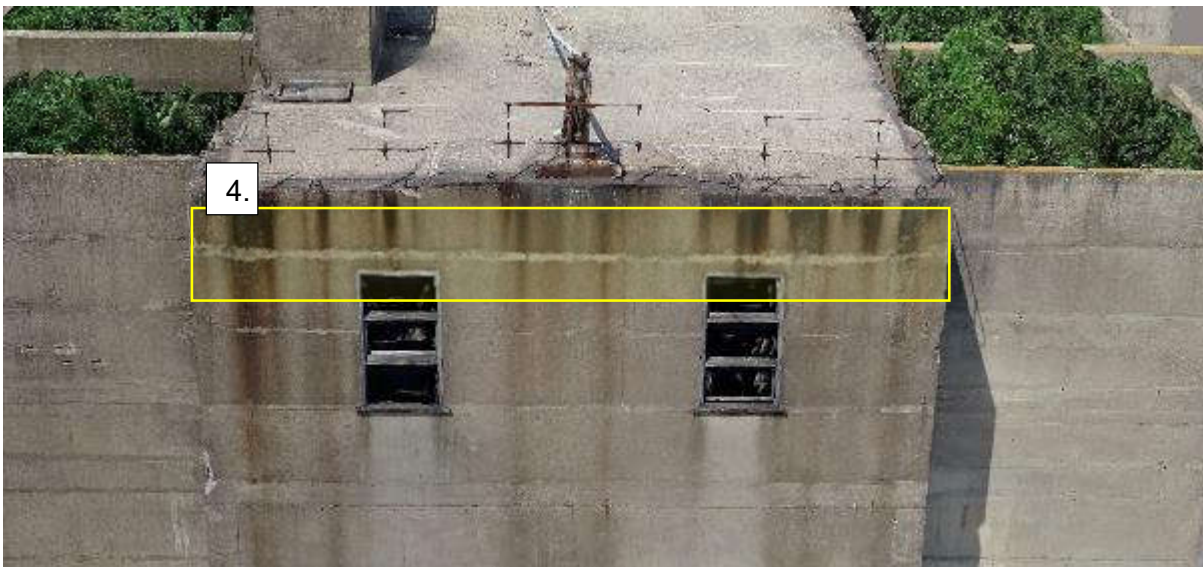
Figure 24: South Elevation - Defect 4

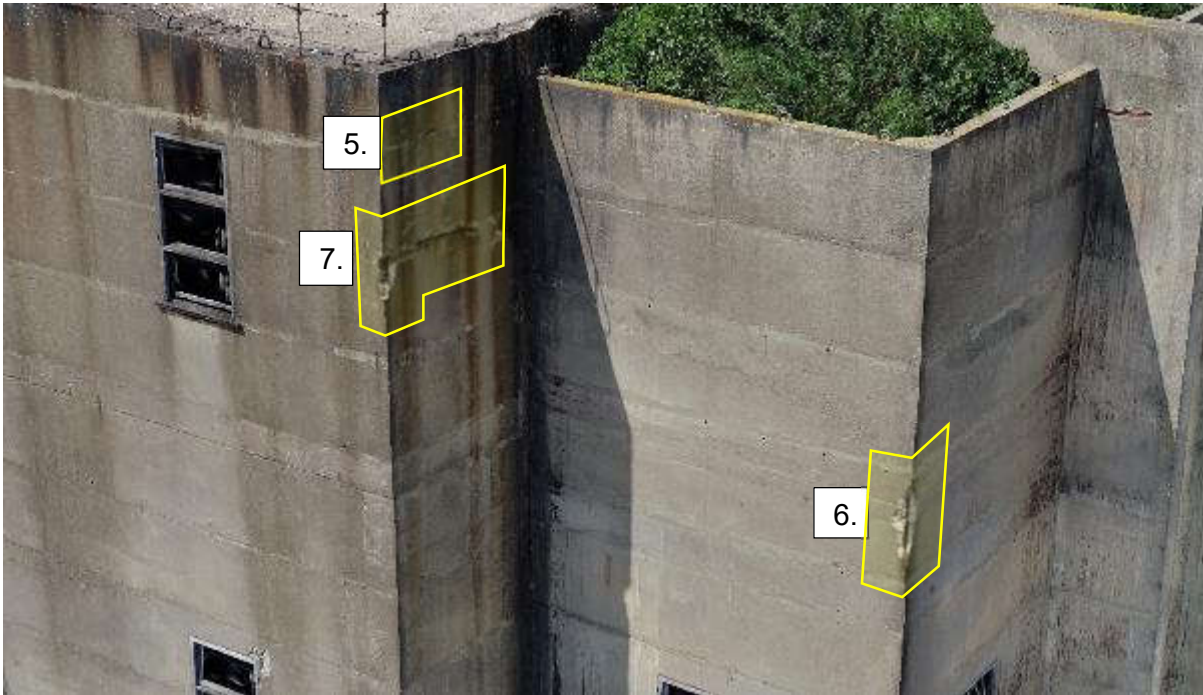
Figure 25: South Elevation - Defects 5-7

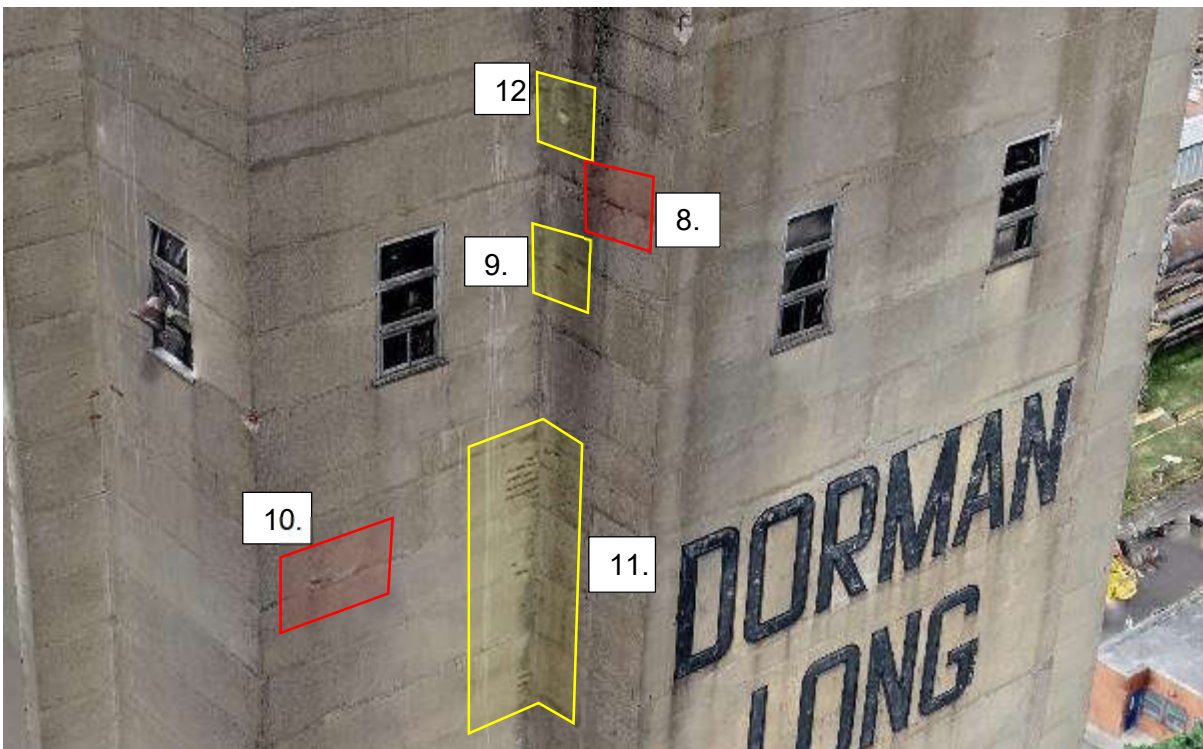
Figure 26: South Elevation - Defects 8-12

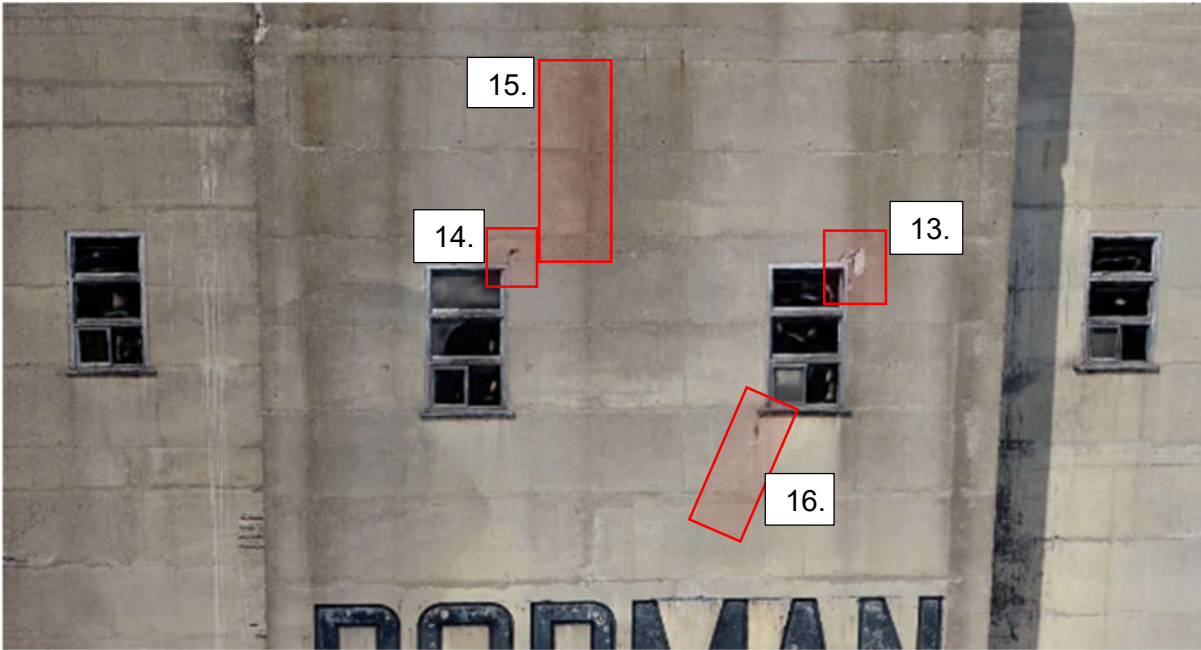
Figure 27: South Elevation - Defects 13-16

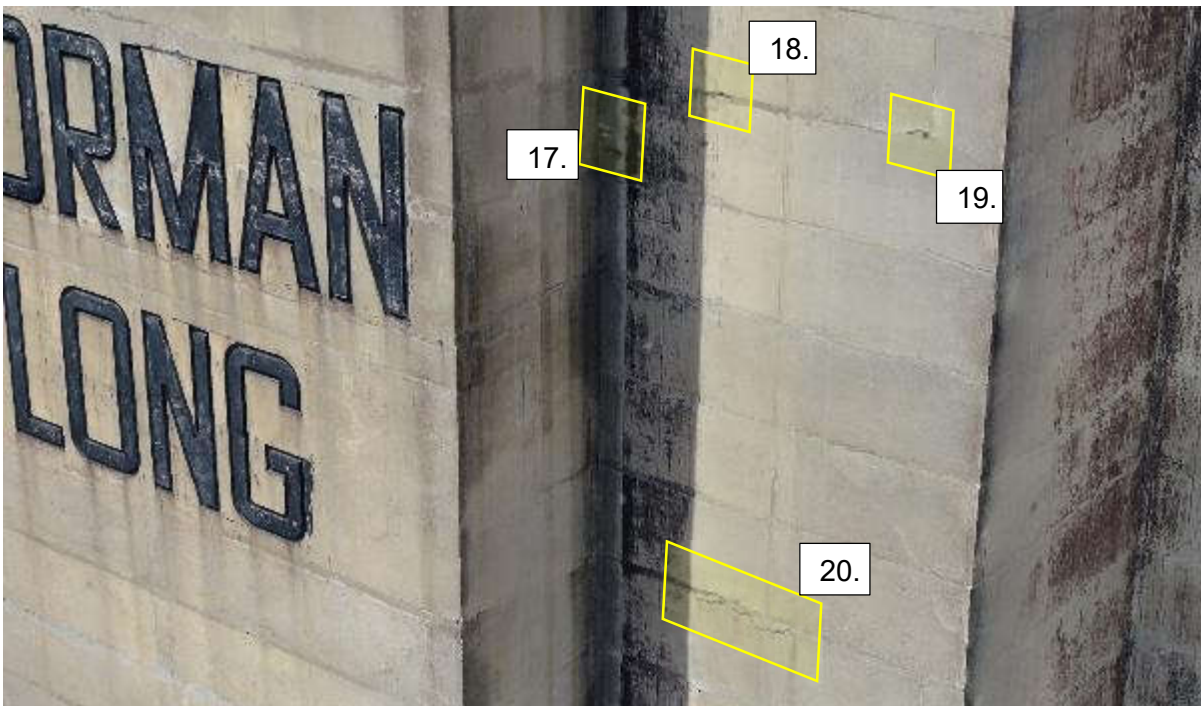
Figure 28: South Elevation - Defects 17-20

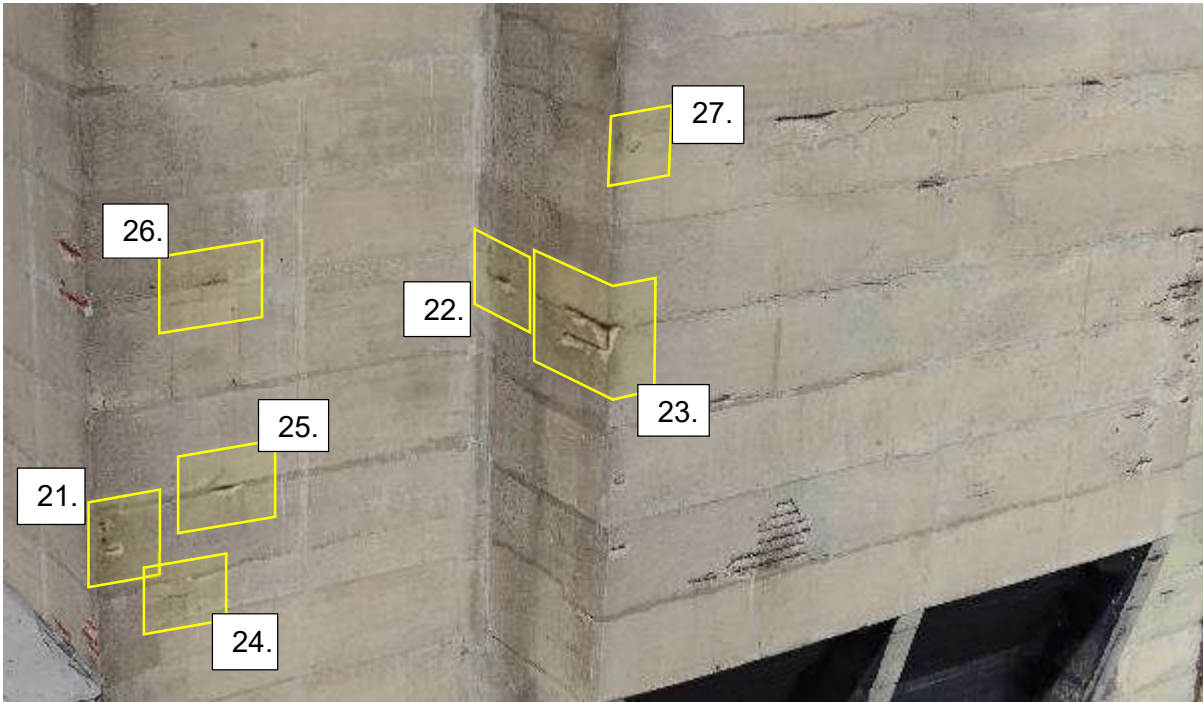
Figure 29: South Elevation - Defects 21-27

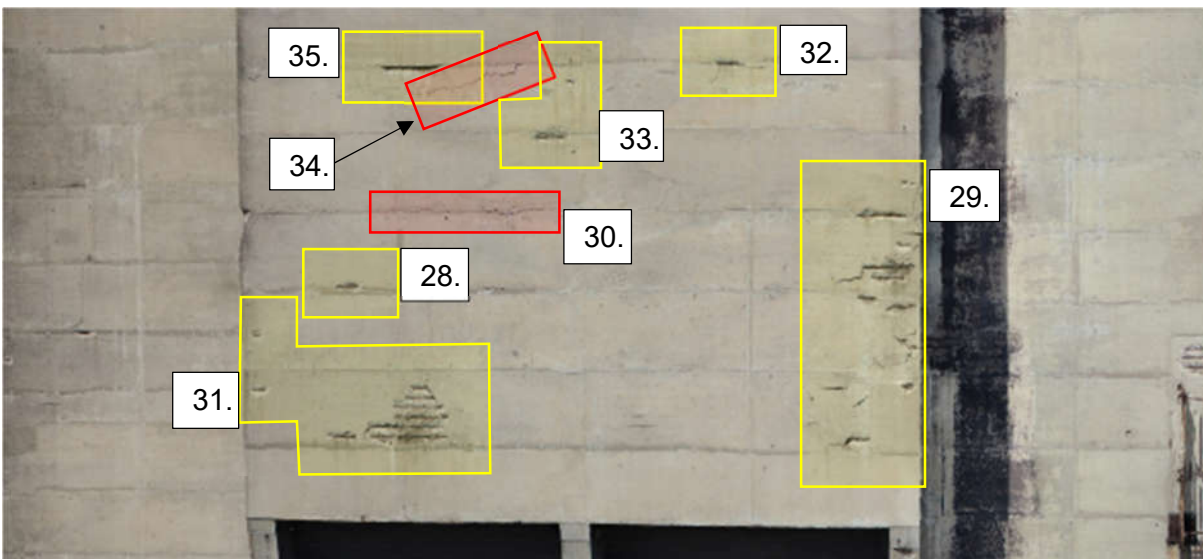
Figure 30: South Elevation - Defects 28-35

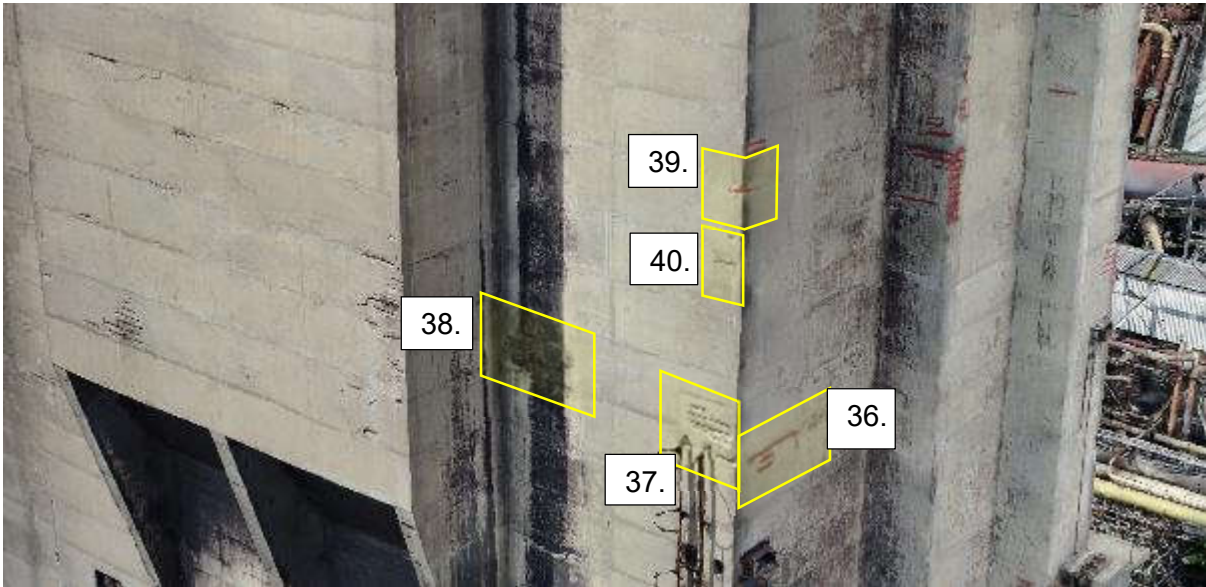
Figure 31: South Elevation - Defects 36-40

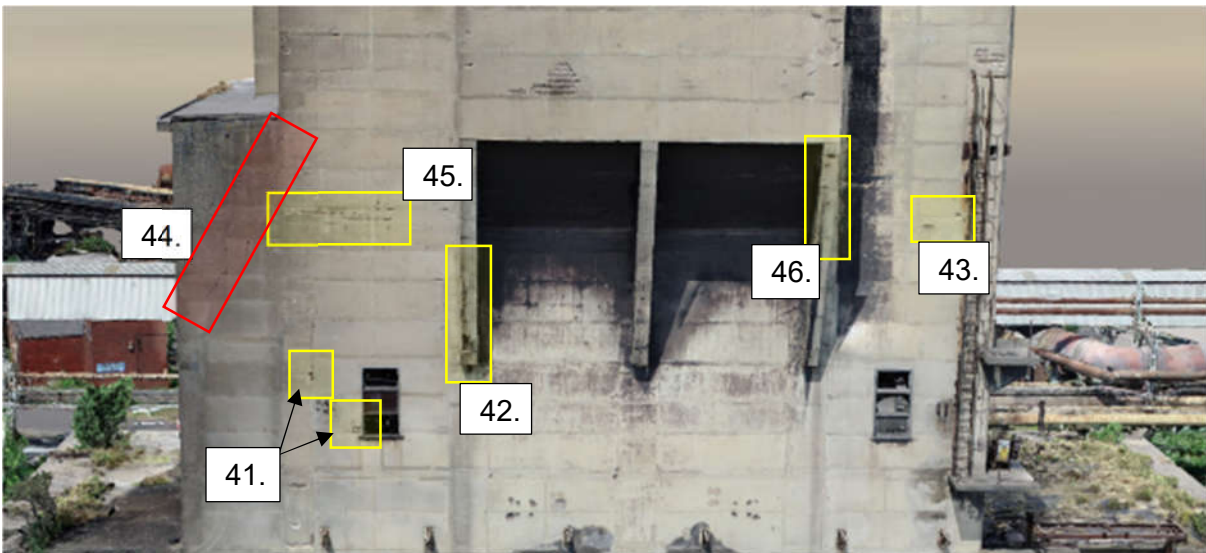
Figure 32: South Elevation - Defects 41-46

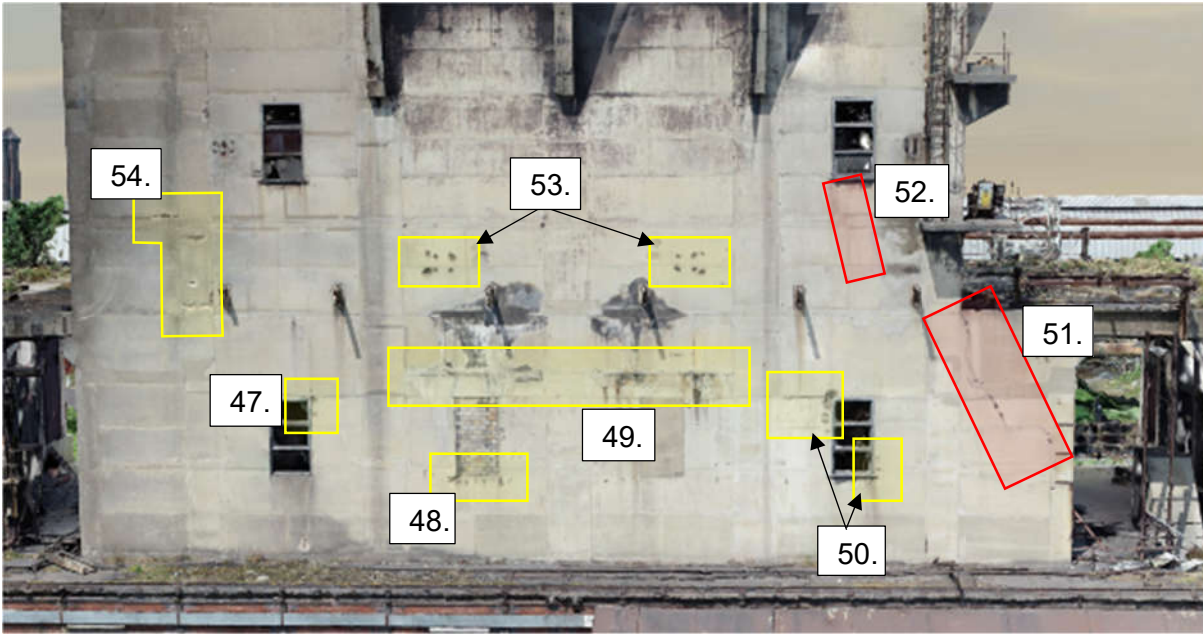
Figure 33: South Elevation - Defects 47-54

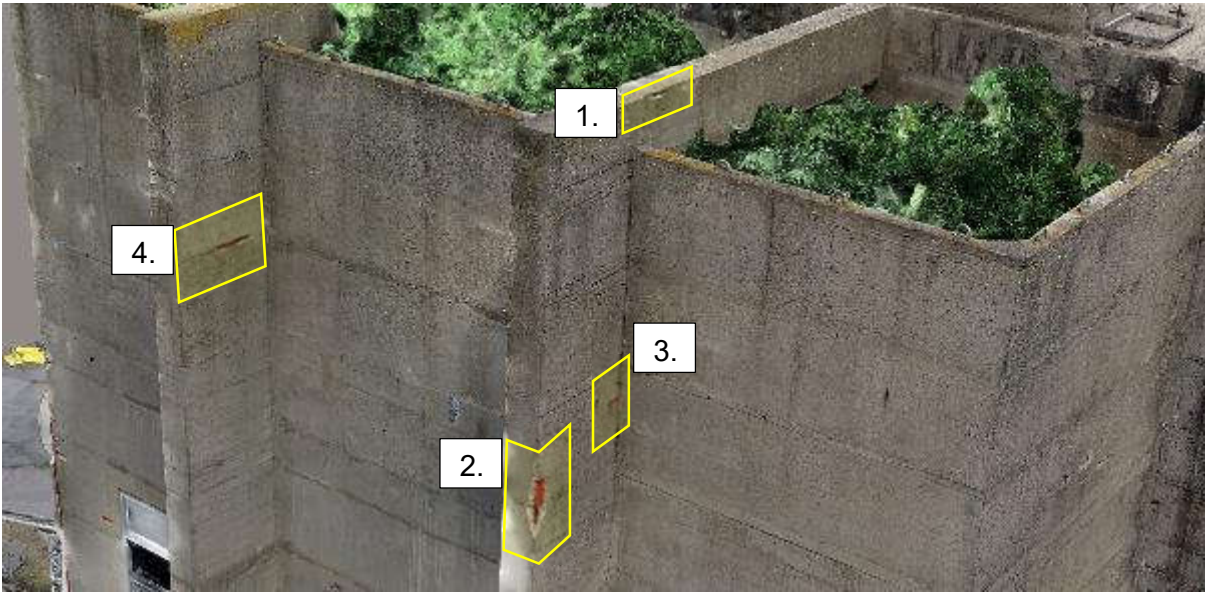
Figure 35: West Elevation - Defects 1-4

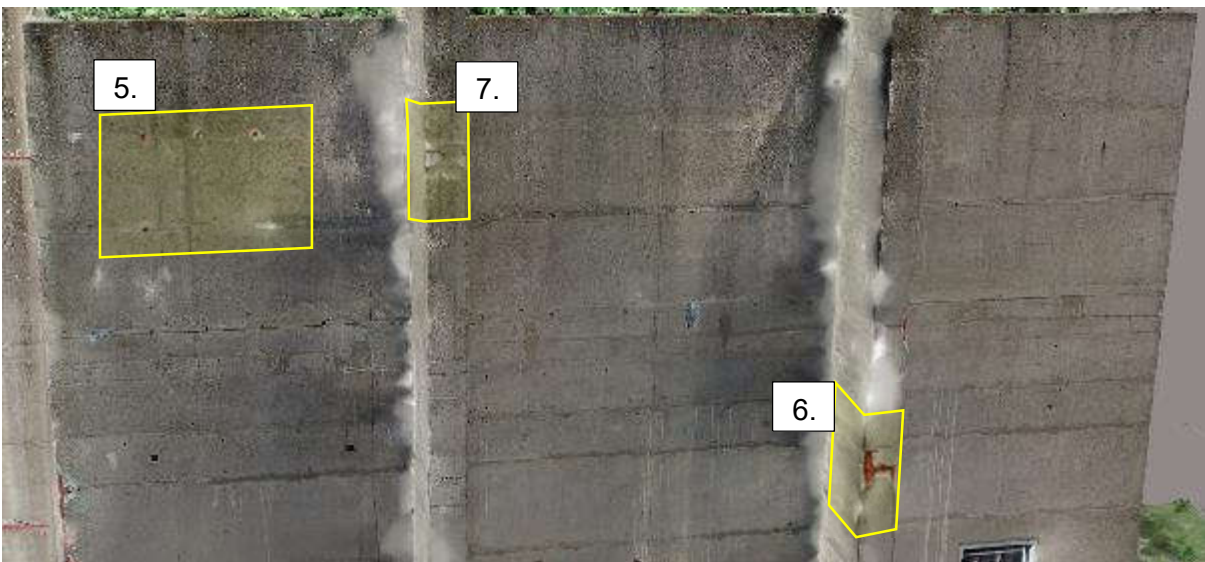
Figure 36: West Elevation - Defects 5-7

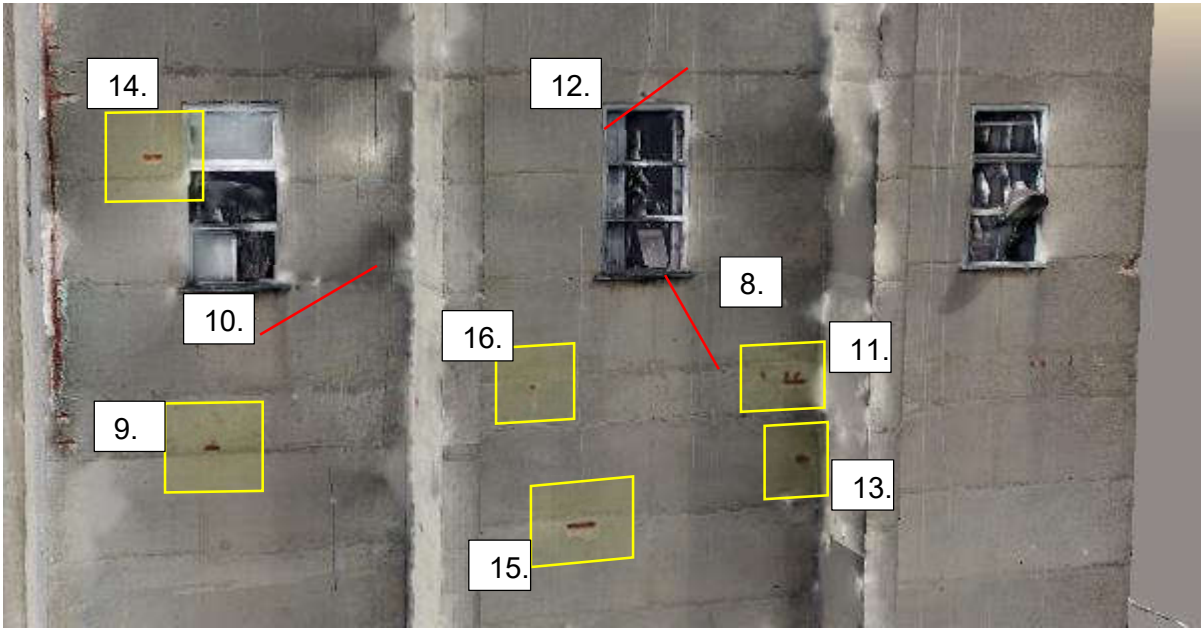
Figure 37: West Elevation - Defects 8-16

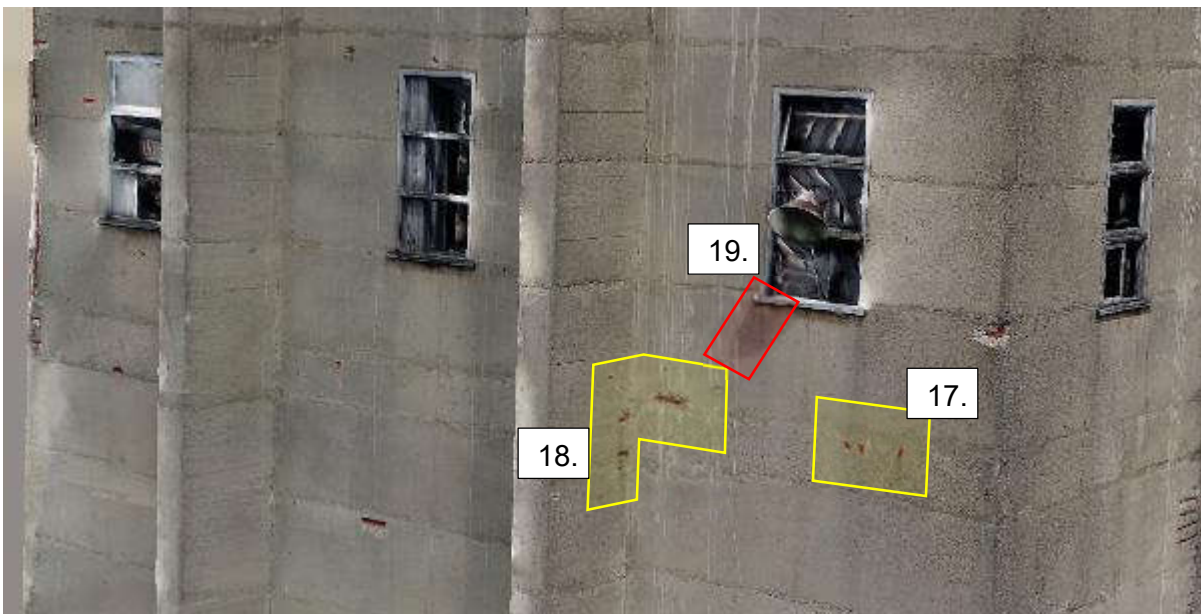
Figure 38: West Elevation - Defects 17-19

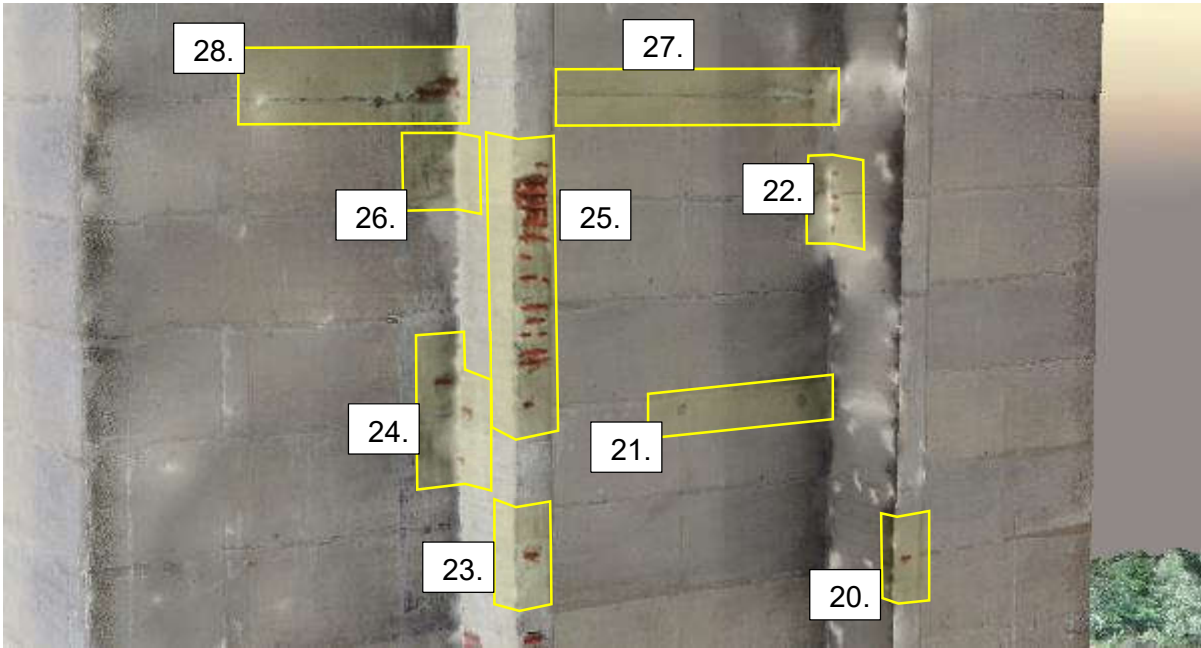
Figure 39: West Elevation - Defects 20-28

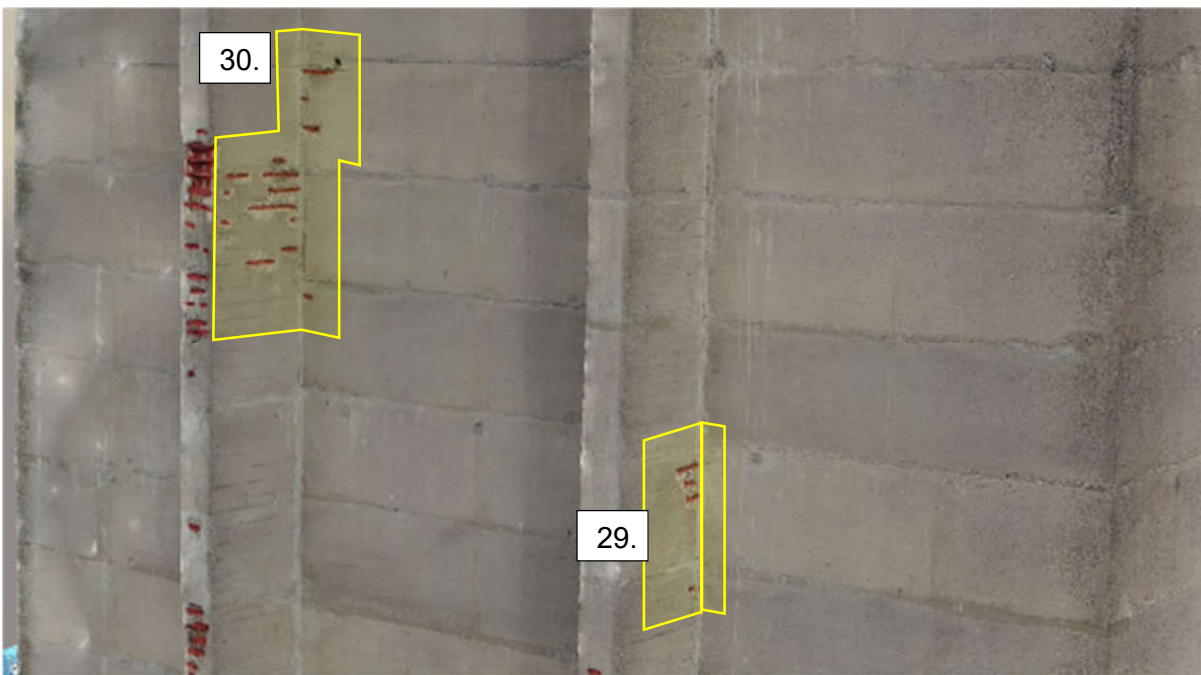
Figure 40: West Elevation - Defects 29-30

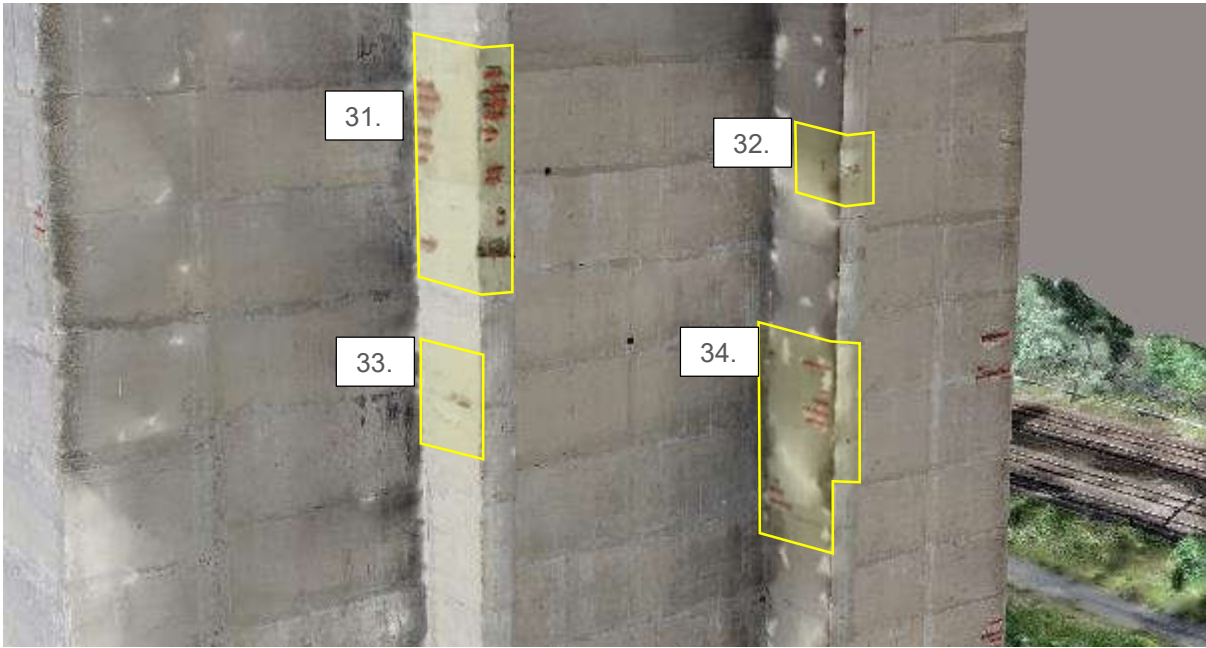
Figure 41: West Elevation - Defects 32-34

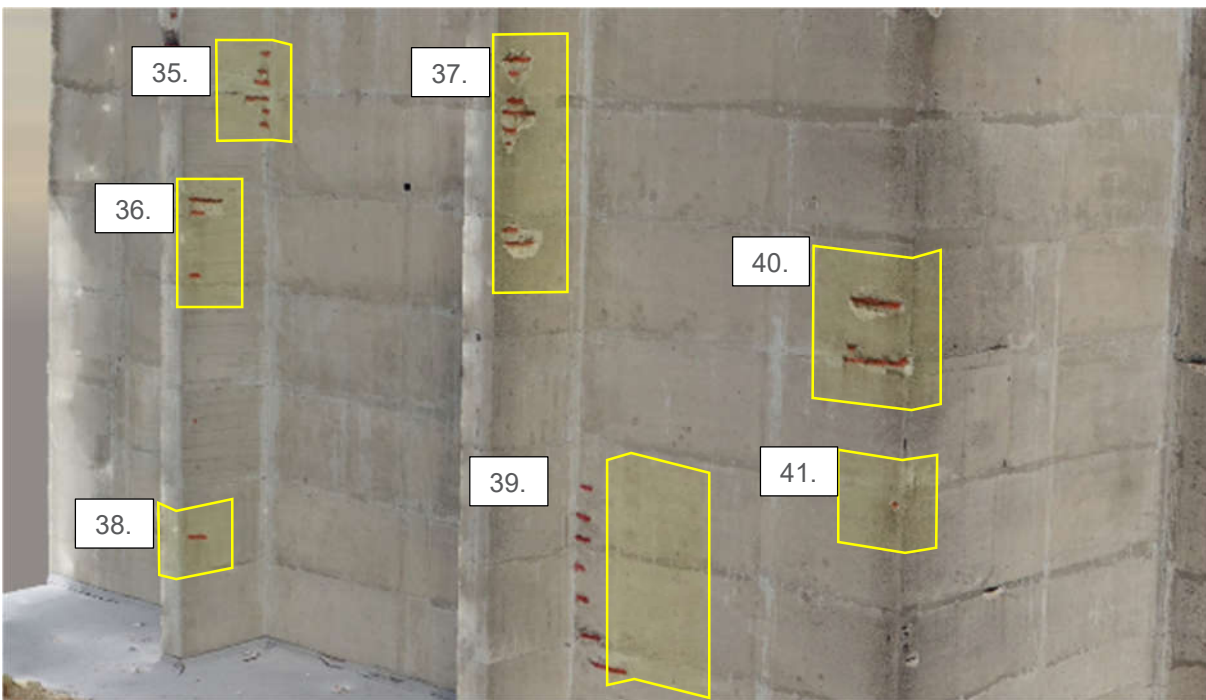
Figure 42: West Elevation - Defects 35-41

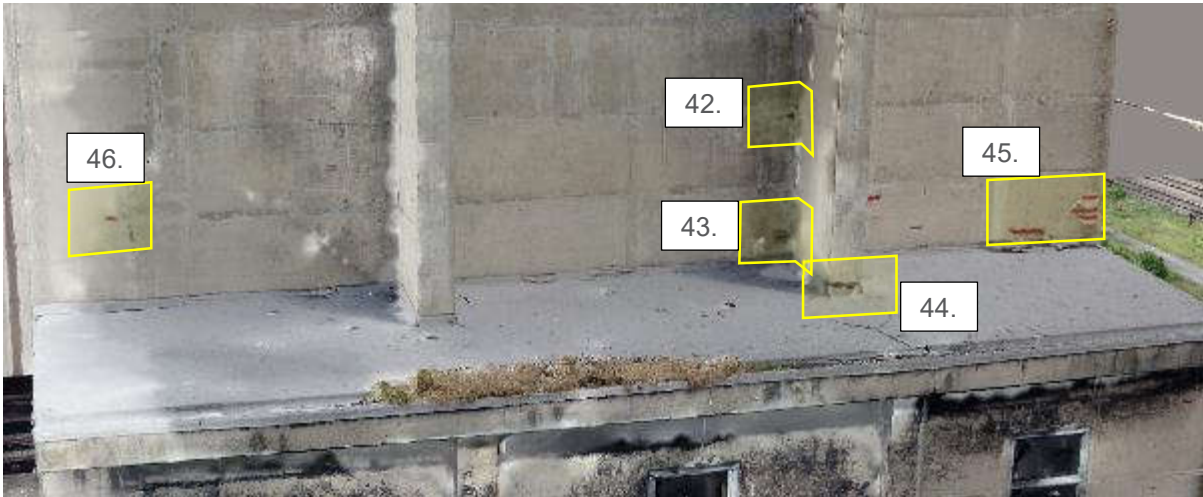
Figure 43: West Elevation - Defects 42-46

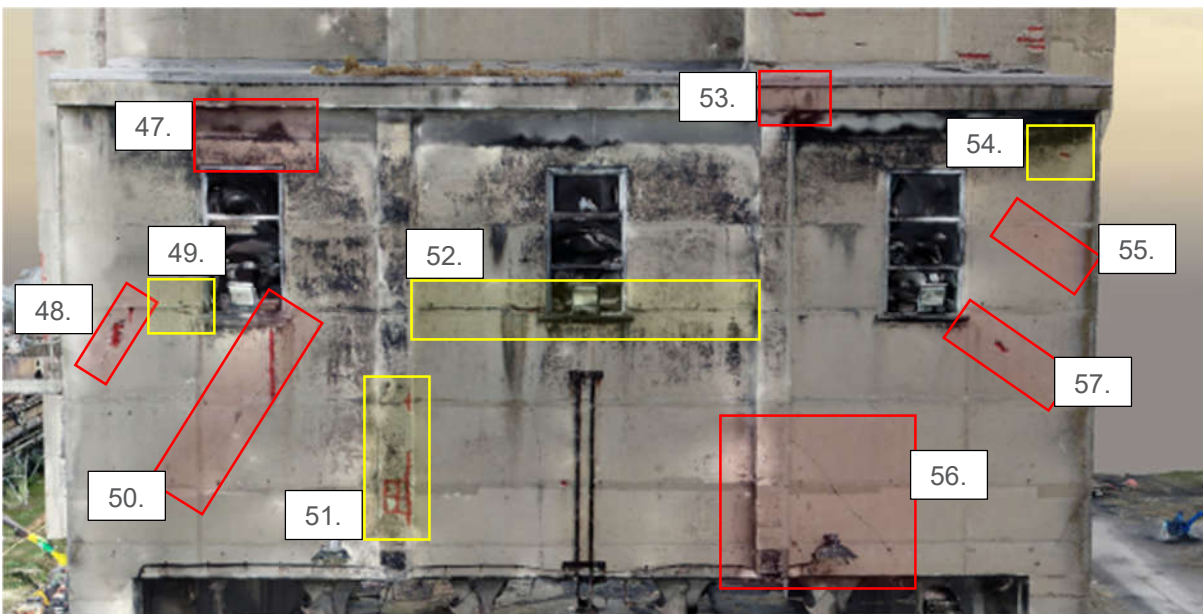
Figure 44: West Elevation - Defects 47-57

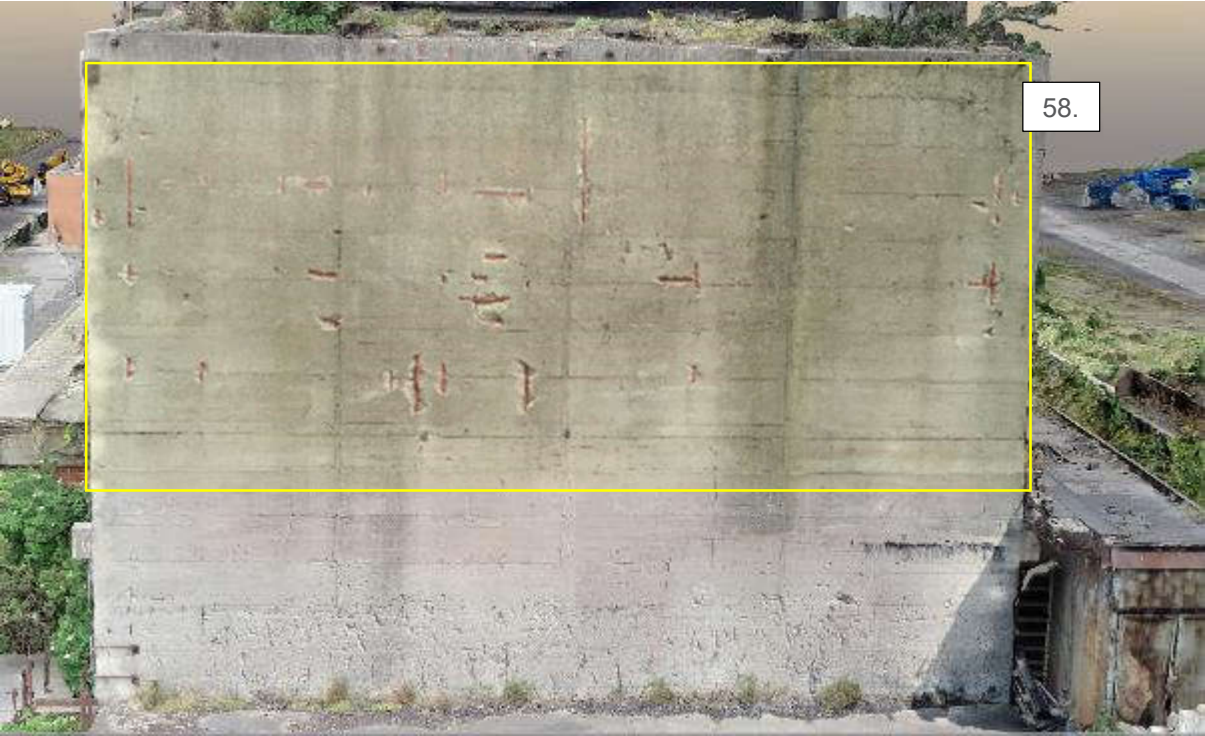
Figure 45: West Elevation - Defect 58
