Dorman Long Tower South Bank, Teesworks

South Tees Development Corporation

Structural Appraisal Report

Document reference: STDC-ATK-SBK-ZZ-RP-S-0001

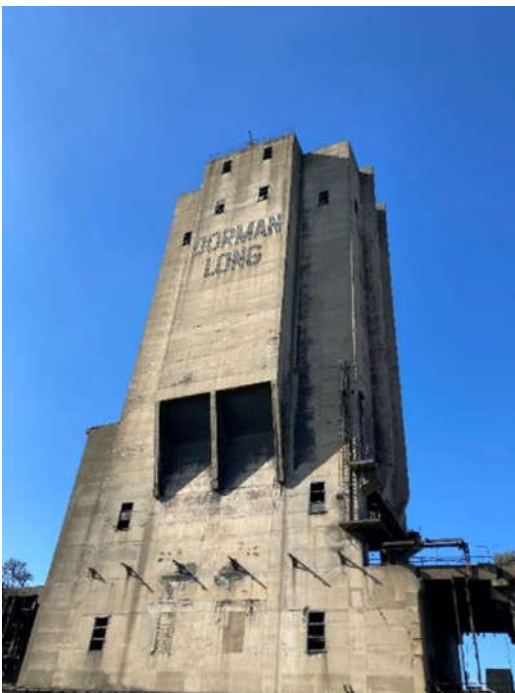
Figure 2.1 Current southern elevation.
